Presented at the FIG Working Week 2016,
May 2-6, 2016 in Christchurch, New Zealand

EQ Response

- Mark Christison
- David Heiler
- Amber Murphy
- Greg Offer

Damage Investigation and Analysis

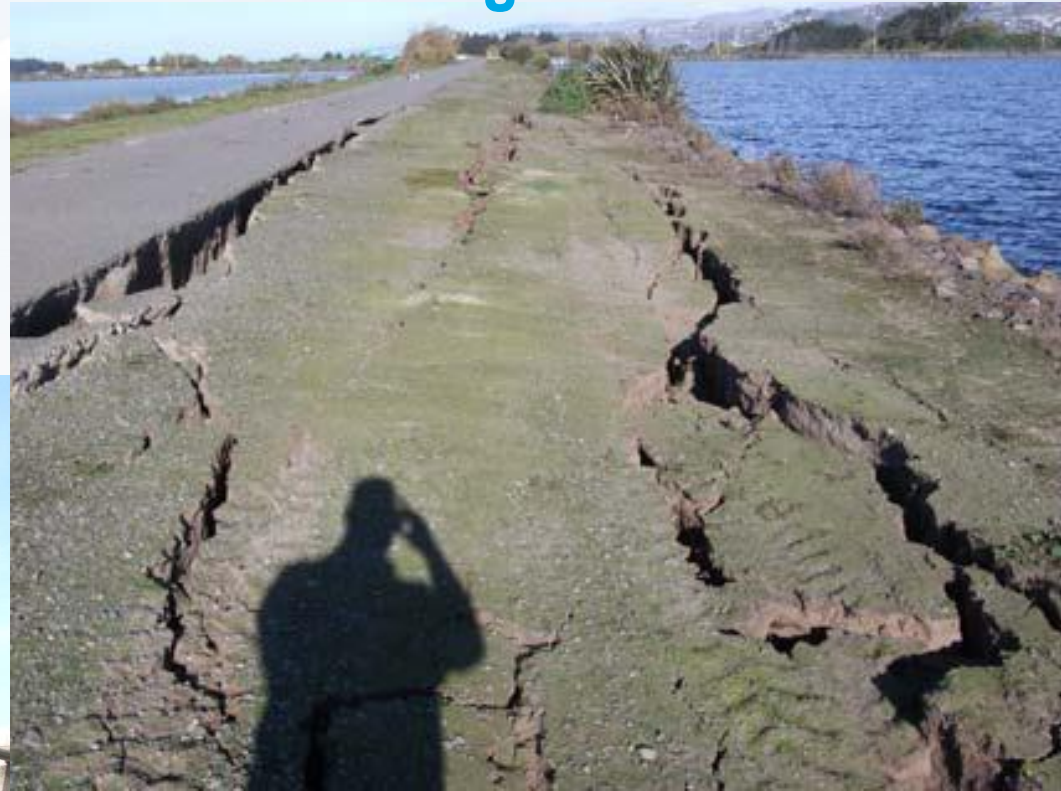
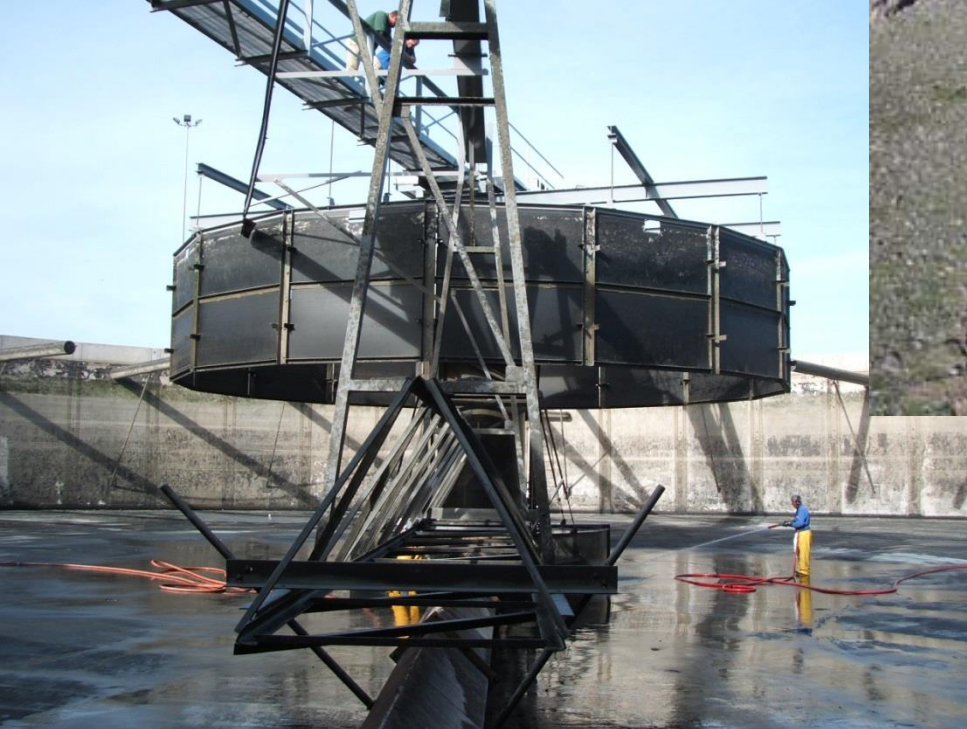
Wastewater Treatment Plant & Network Damage

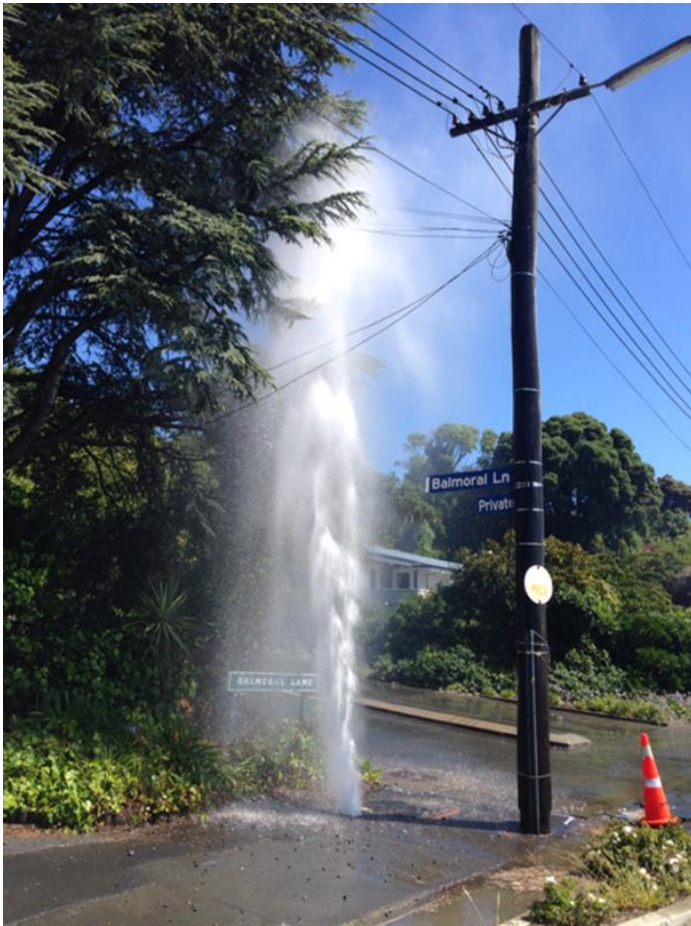
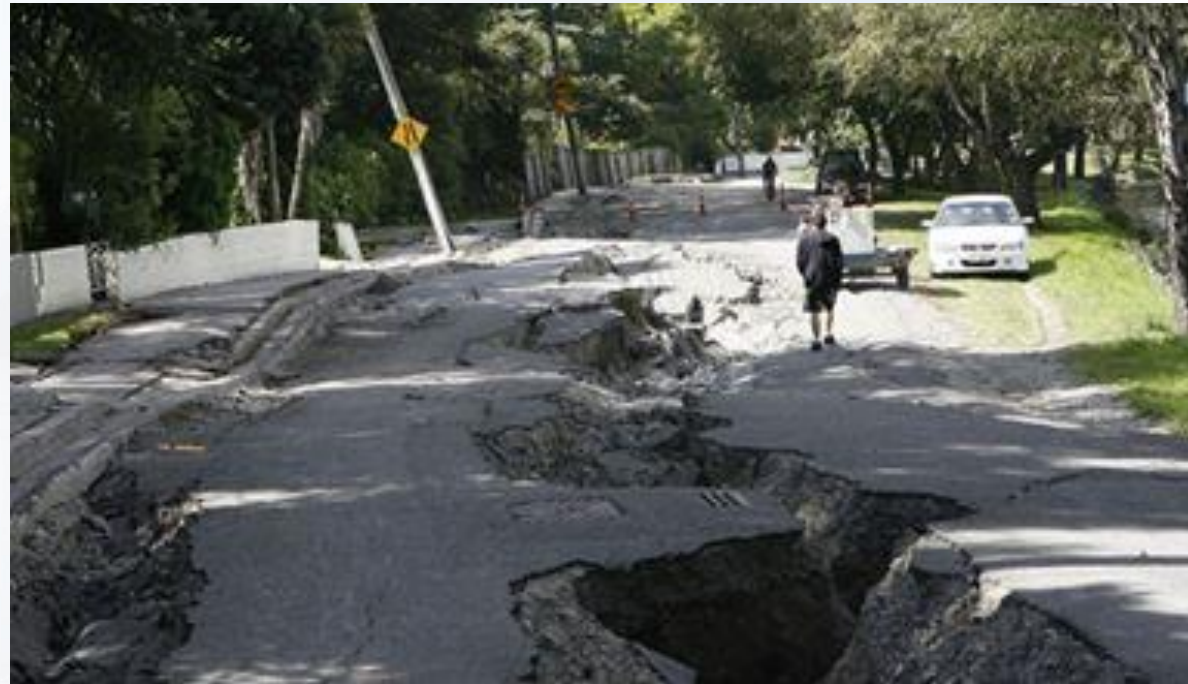
Some Damage Visible

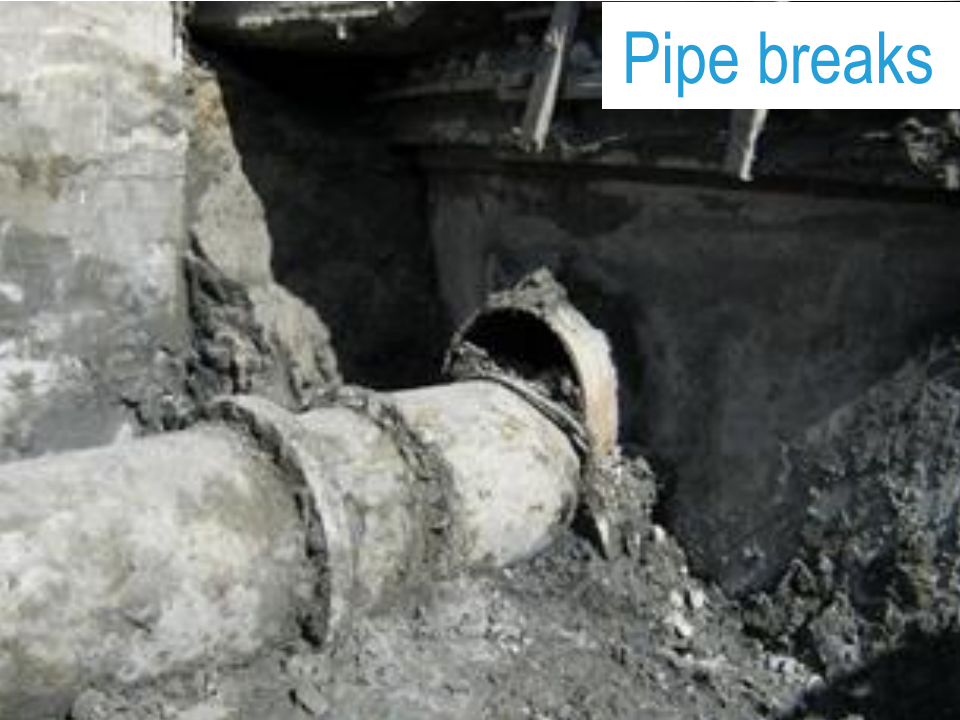
Pipe breaks

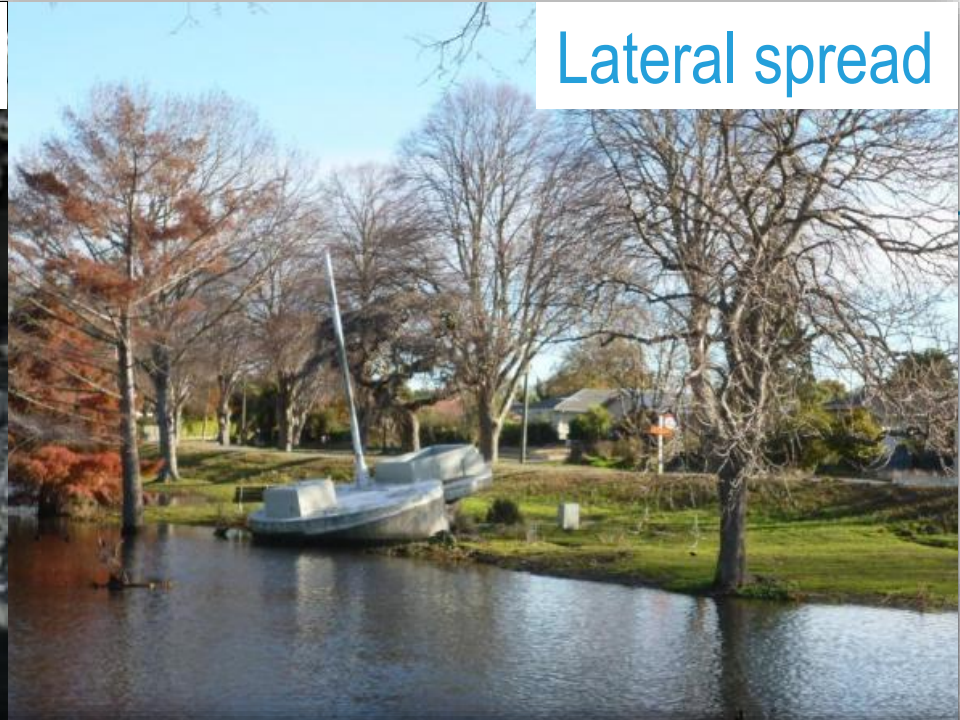
Lateral spread

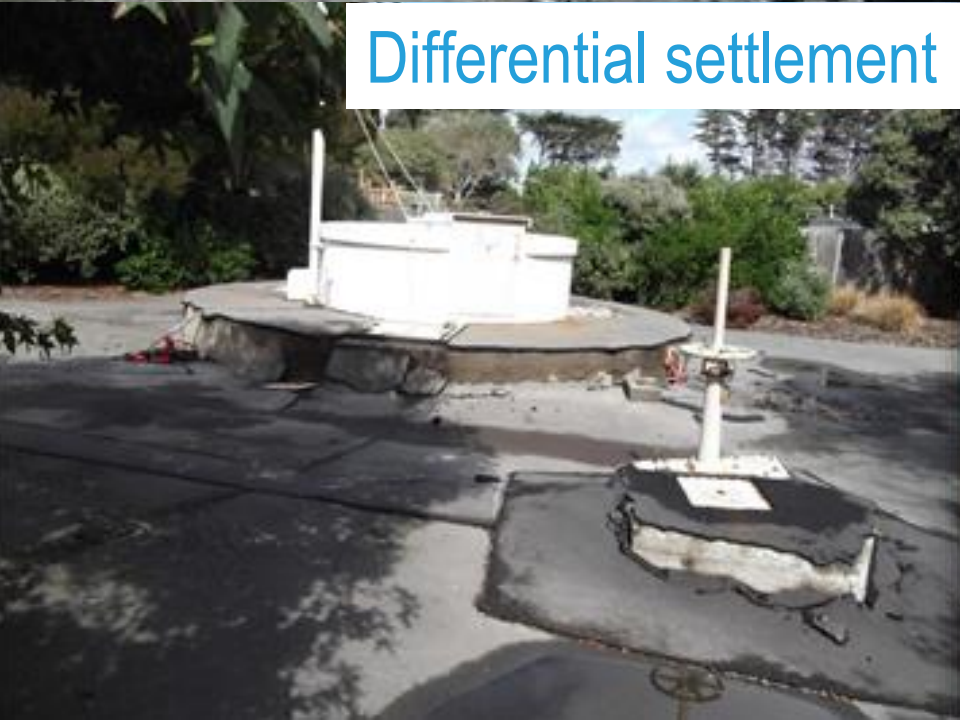
Differential settlement

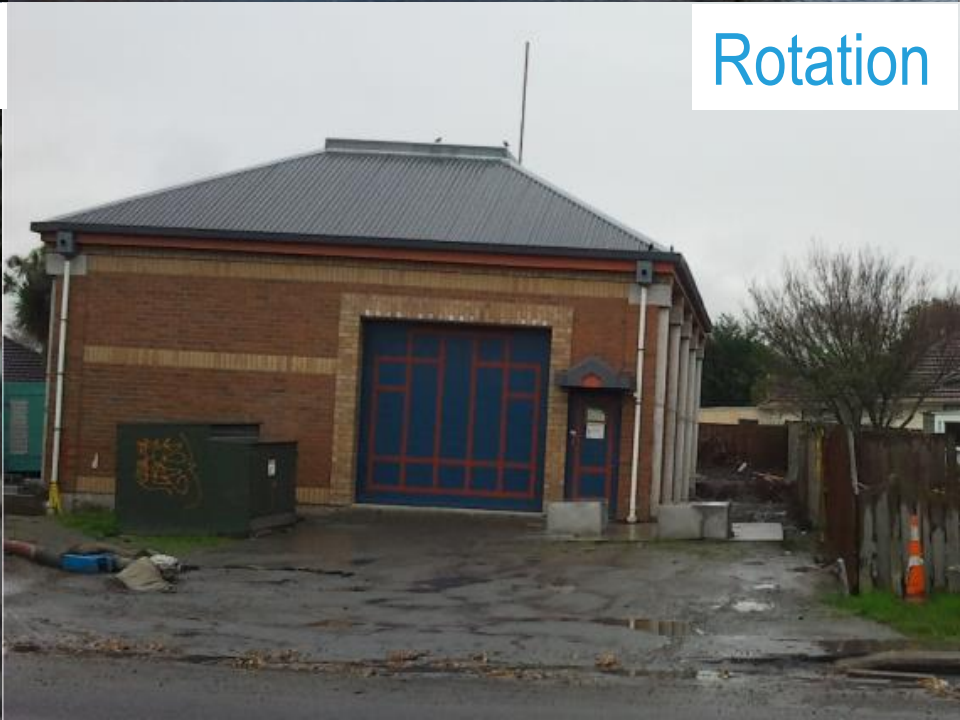
Rotation

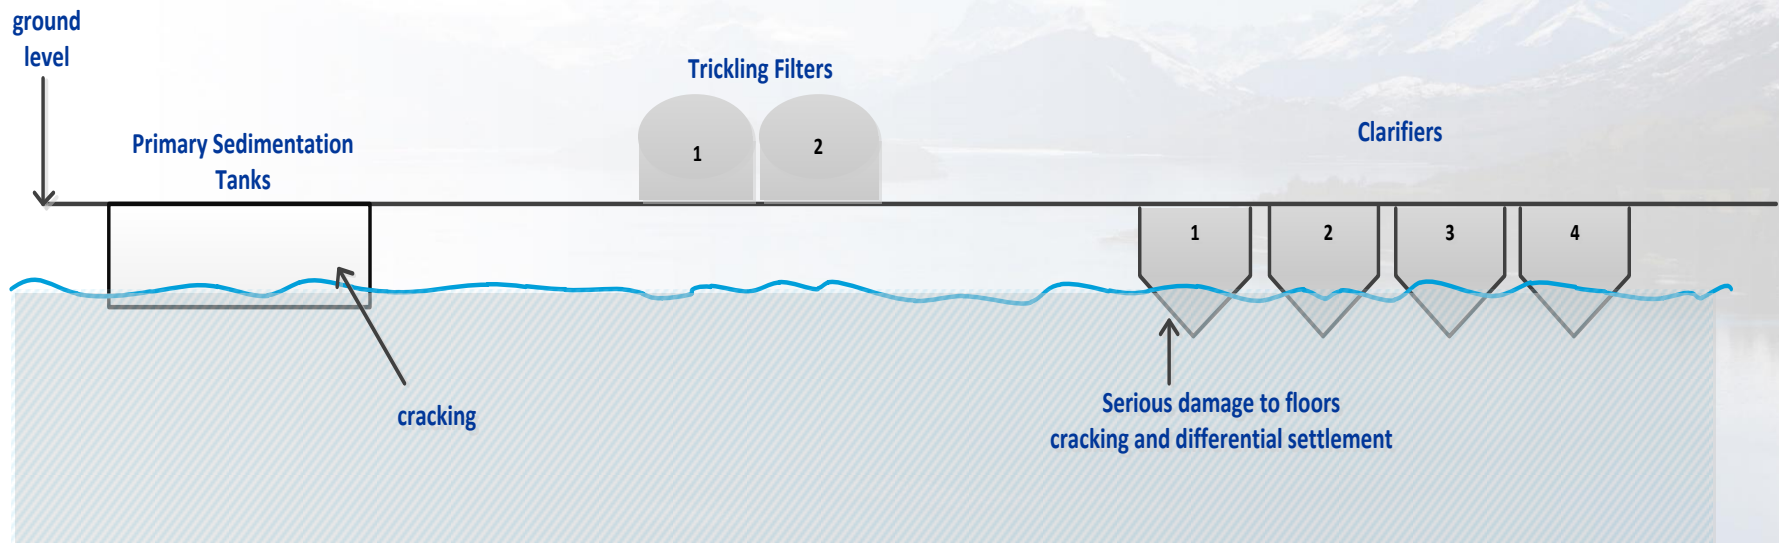
Earthquake impacts

- Shallow structures ok
- Deeper structures seriously damaged

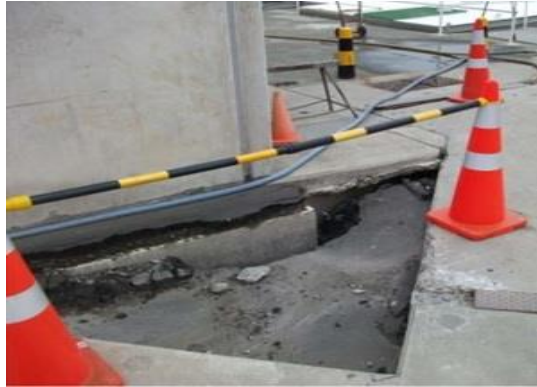
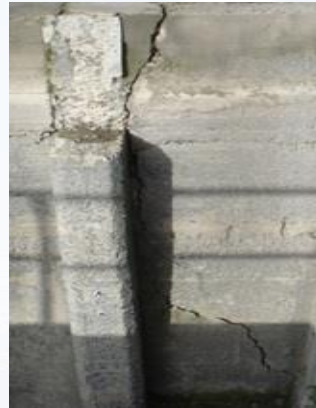
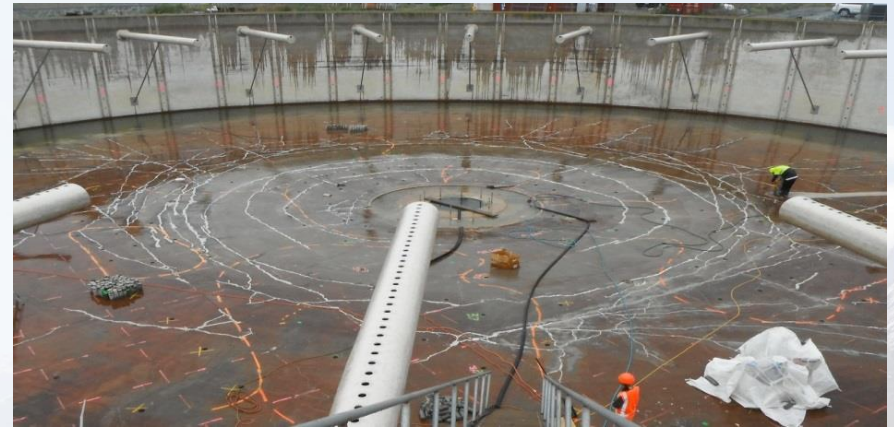
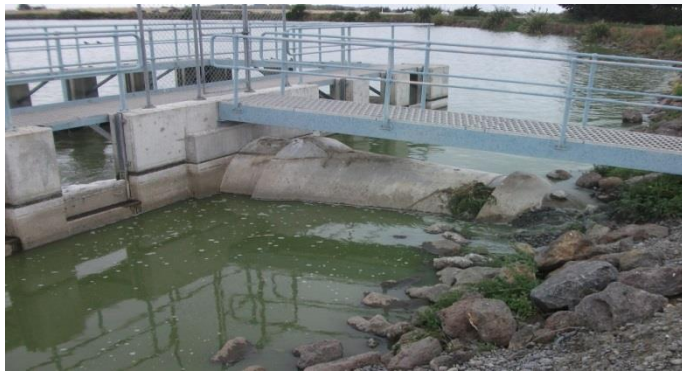
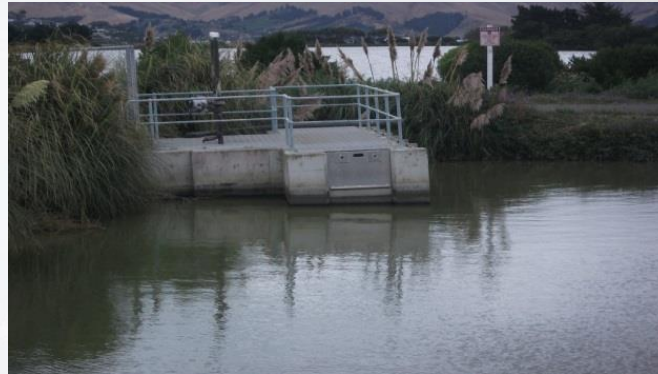
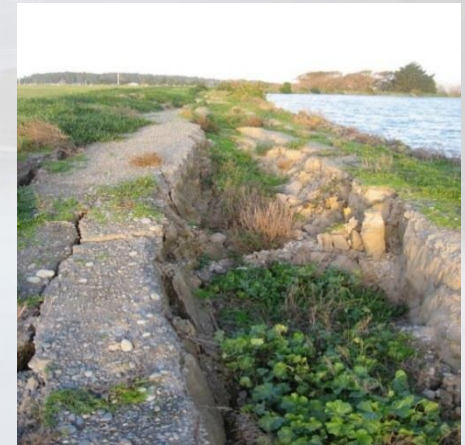
Treatment plant & pond damage

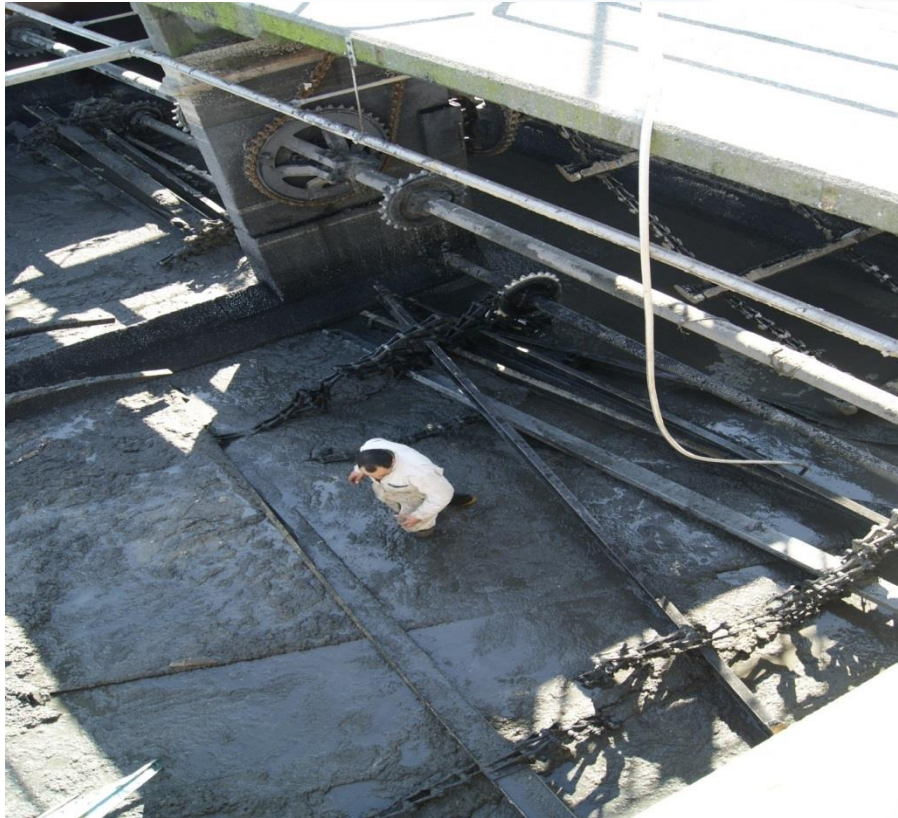
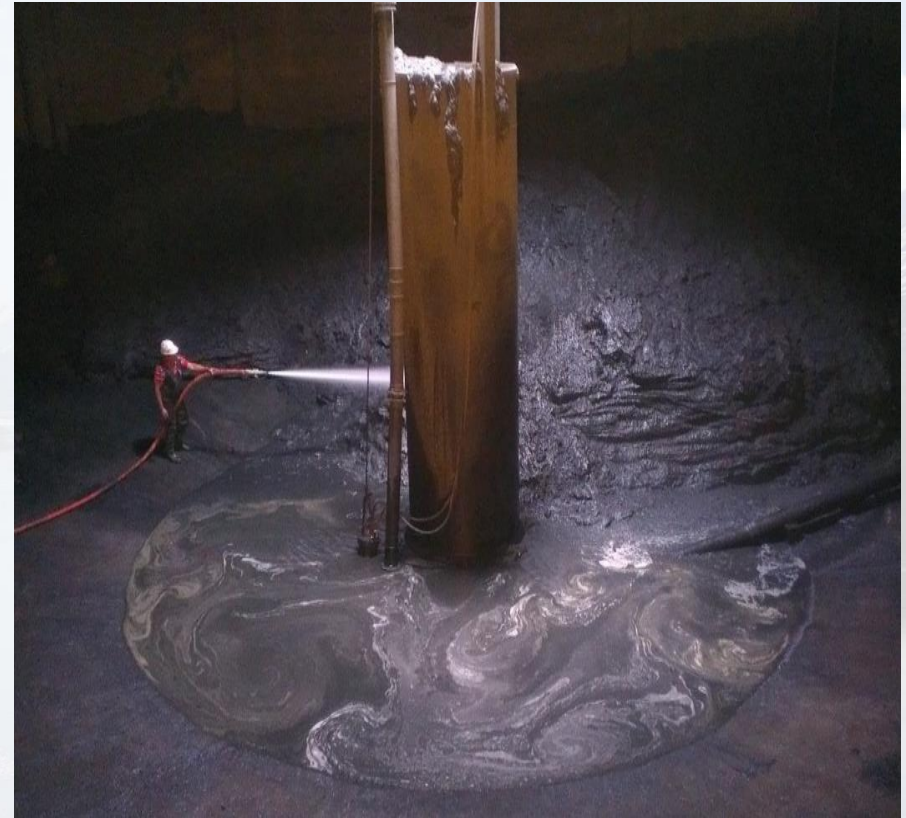
Sand ingress in grit, primary sedimentation and digesters !

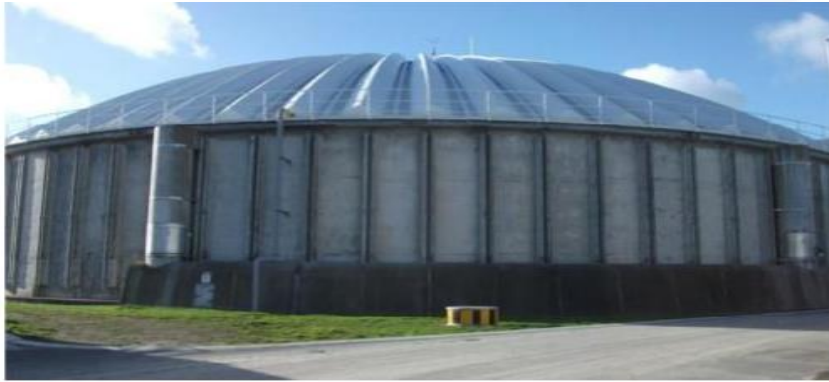
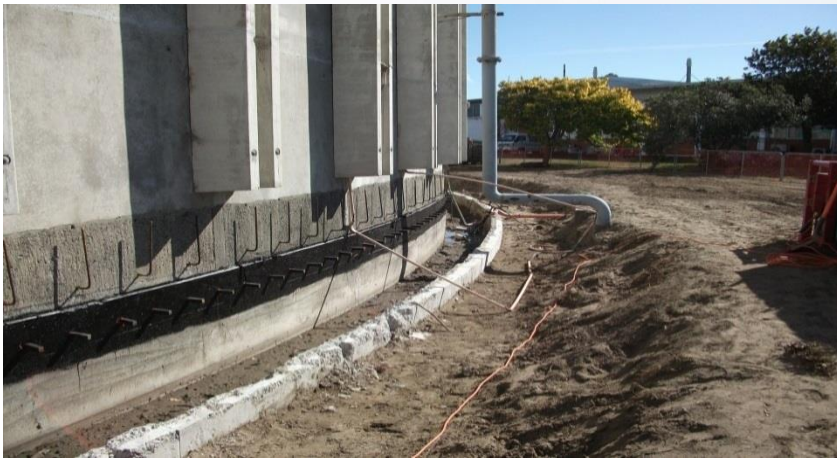
Trickling filters

- Built at shallow depth so lightly damaged
- Some media and rotating arm damage
- External ring beam to strengthen tank
- Online 24/7 means inspection difficult... insurer wants “whole of site settlement”

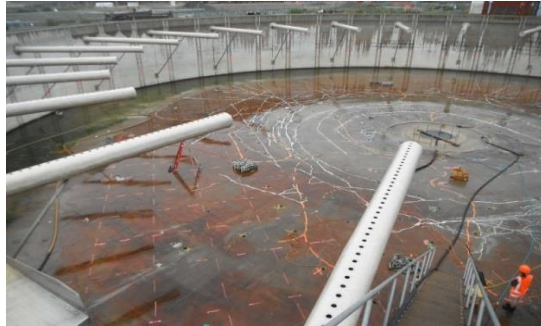
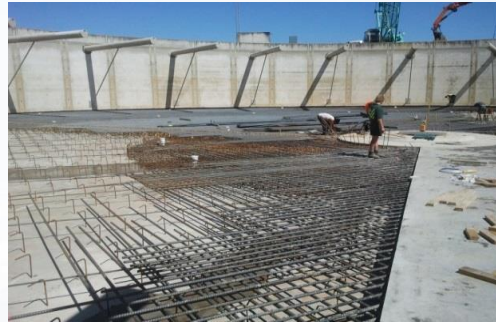
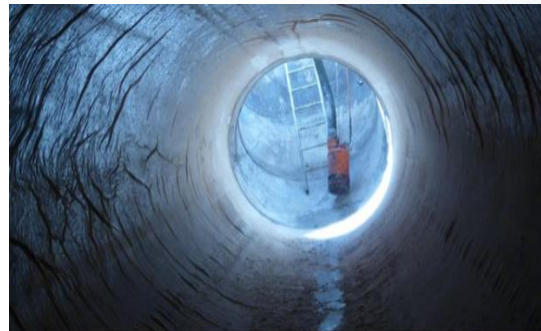
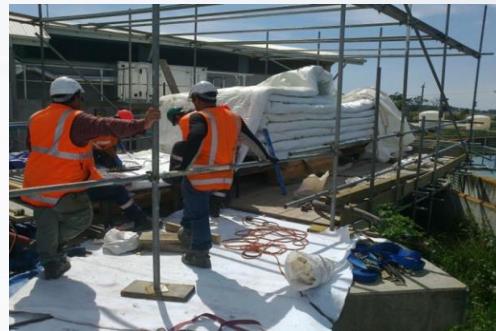
Clarifiers

- Two clarifiers severe damage, two minor damage
- Liquefaction pore pressures caused floor deformation
- Repairs based on reinforced concrete overlay
- Cure-in-place liner installed on inlet pipes
