Assessment of cracks on concrete dams by image processing. The Case-study of Itaipu dam, at the Brazil-Paraguay border

Jónatas VALENÇA, Eduardo S. JÚLIO

CERIS, Instituto Superior Técnico, Universidade de Lisboa
Lisboa, Portugal

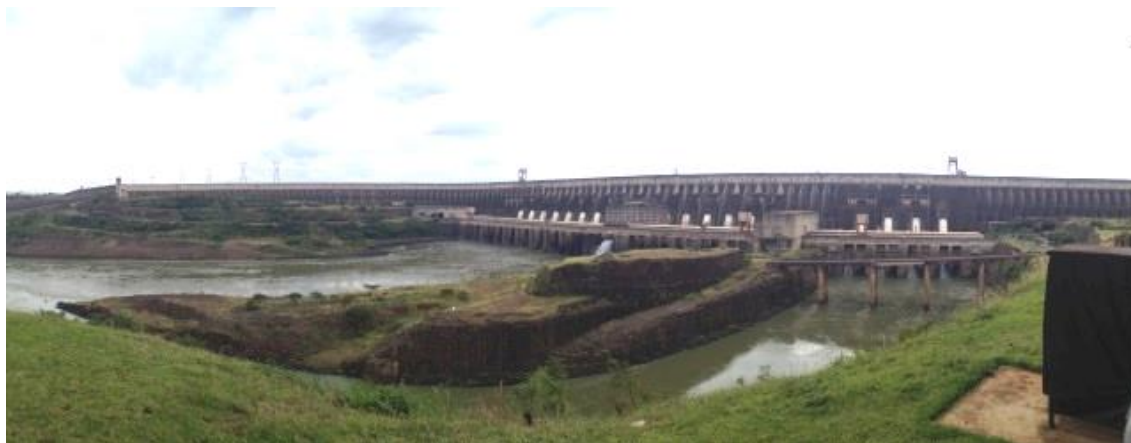
Figure 1. General downstream view of Itaipu dam.

The Itaipu Dam (Figure 1) is an infrastructure located in the Paraná River, at the border between Brazil and Paraguay. Its reservoir goes from Foz do Iguaçu in Brazil and Ciudad del Este in Paraguay, to Guáira and Salto del Guaira, respectively, about 150 km north. The 20 turbines of Itaipu Dam has an installed power generation of 14,000 MWh, just recently exceeded by the Three Gorges Dam in China (Caetano de Souza 2008). In 2008 it generated a record amount of 94.7 TWh, and provided 87% of Paraguay's energy and 19% of Brazil's energy (Rivarolo *et al.* 2012; Itaipu-Binacional 2015). Since the beginning of its construction, the Itaipu Dam has been concerned to monitor the behaviour of the structure (concrete, rock-fill and earth-fill), and of several mechanical and electrical components. In addition to uses the most modern technology, the Itaipu Dam has invested in-house technological developments, and created the Itaipu Technological Park (PTI) and the Center for Advanced Studies on Dam Safety (Ceasb) for that purpose (PTI-Ceasb 2015).

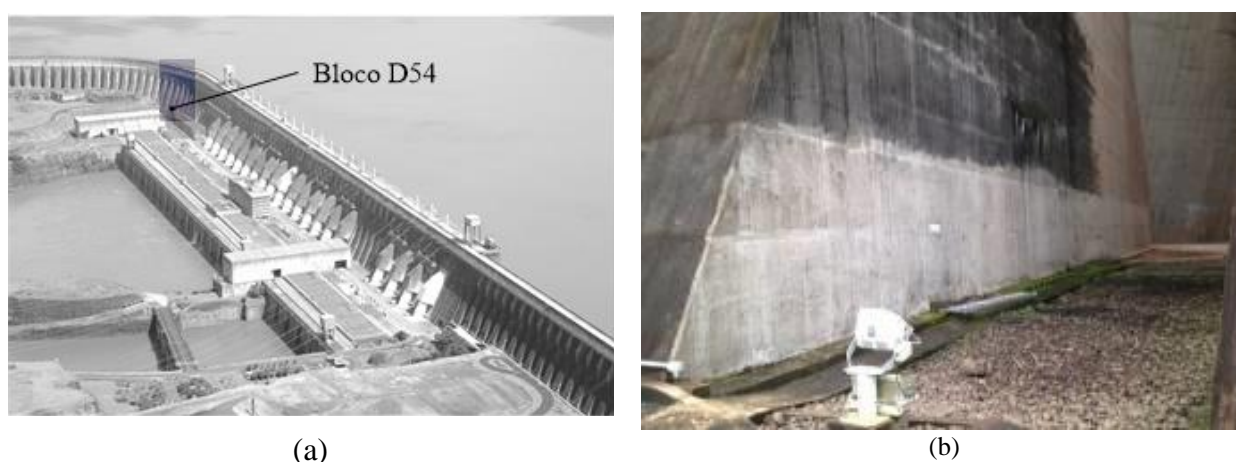
Figure 2. Itaipu dam, block D54: (a) location; (b) surface to assess.

In this paper, only the issue of detection and monitoring of cracks in the concrete dam will be addressed. These results mainly from the construction phase and do not represent any alarm signal. Its regular assessment has been carried out by a specialized inspection team, using traditional methods, including visual observation and width measurement through graduated magnifiers. However, given the huge size of the infrastructure, this survey is labor intensive and time-consuming, highly dependent on the technicians, and practically impossible to be carried out systematically, especially at high levels. The Itaipu Dam includes a set of structures: earth-fill dam, rock-fill dam and concrete dam, including the spillway. To validate the applicability of the method presented to the concrete dam, an area-of-study was defined by the inspection team. This consists of a region with about 4.5 m height and 40 m length, in the base block D54 (Figure 2a). The selected region presents biological colonization and a wind-area rain, and has been previously cleaned with water jet, having removed all the material deposited on the surface (Figure 2b).

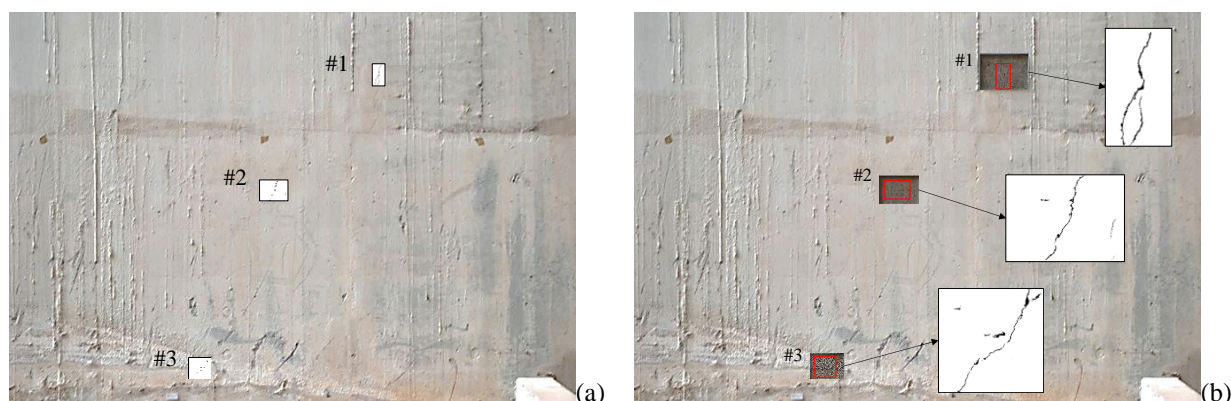
Figure 10. Map of critical cracking areas analysed: (a) location of the areas analysed; (b) zoom of the local areas.

In the final map (Figure 10a), the cracks are identified with less resolution, in order to allow easy and fast navigation and visualization. However, detailed analysis of critical regions can subsequently be performed throughout the crack. The user will be able to access any region of a given crack and to select and detail analyze the sections of interest (Figure 10b).
