# Displacement and surface pathology monitoring of former Tejo Power Station building by combining terrestrial laser scanning, micro-geodesy, photogrammetry and GIS

Adriano OLIVEIRA, João BOAVIDA, Bruno SANTOS

Artescan, 3D Scanning, IPN TecBis, Edif. E  
Coimbra, Portugal

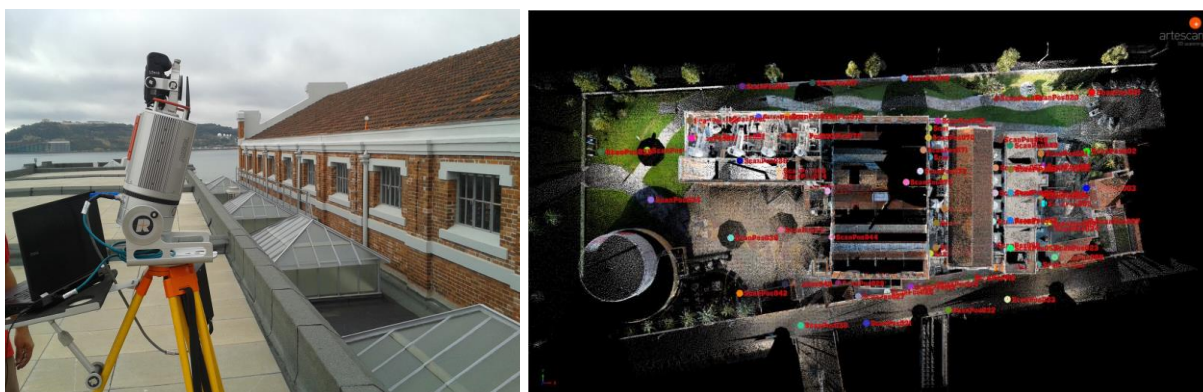
Fig. 3 TLS and photogrammetric survey acquisition (left) and resulting point cloud (right)

The complete coverage of the buildings complex took 86 laser scanning stations, all around the area under study, as well as on top of the terraces and roofs. For each station, laser data and image were acquired. Point clouds were acquired with a point density on the object of more than 3 cm, and photogrammetric images were acquired with resolution on the object better than 0.8 cm/pixel. The radiometric data acquired by the camera was merged with the geometric data of the TLS, thus providing a coloured point cloud (X, Y, Z, R, G, B).

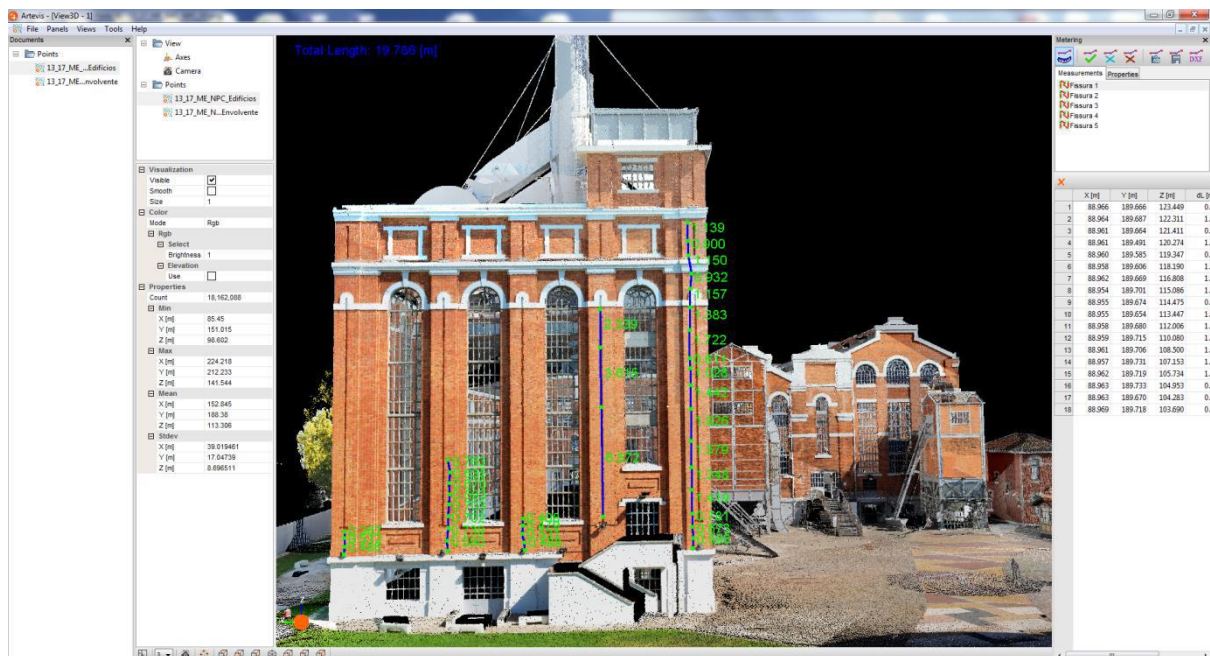
Point cloud registration was accomplished by using retroreflectors as 3D tie points, distributed around the area and surveyed with a digital total station. A unique 3D coloured point cloud was created with a filtered resolution of 1 point every 3 cm. This point cloud can be visualized, analysed and measured using a point cloud visualization software, as Artevis.

Fig. 4 3D Coloured Point Cloud on Artevis, software for the visualization analysis and measurements of point clouds.

Artevis is a software developed by Artescan which allows for the handling of large data sets of 3D point cloud data in an efficient and user friendly way. Within this application it is possible to manage and explore multiple 3D point clouds by conventional 3D controls (move, pan, rotate etc.), to measure coordinate data as well as partial and total distances, to create 3D vectors and to enhance the visualization of the point cloud by using multiple visualization modes (e.g. coloring by elevation or direction).
