Surveying Response to the Victorian Bushfires of February 2009

Eddie CICHOCKI, Australia

Key words: Bushfire recovery, cadastral infrastructure, volunteer surveyors

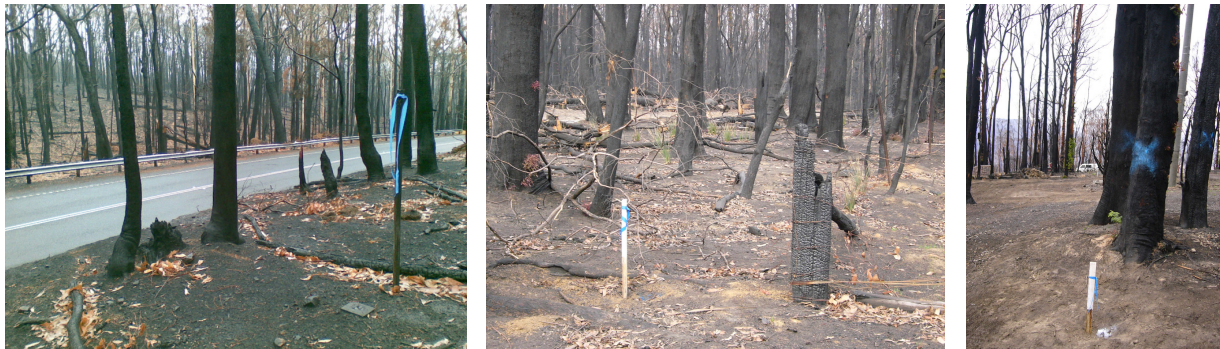
Figure 2 shows examples of permanent marks, reference marks and boundary marks located by surveyors in the fire-affected areas. Once found, the marks were required to be referenced by survey measurement and staked to assist in preserving them during the clean-up works. The colour blue was adopted by the Taskforce as the standard colour for the paint and flagging tape used to indicate the marks found.

Figure 2. (L-R) Permanent mark, reference mark and timber peg found and staked by volunteer surveyors.

Reports from the volunteer surveyors were that permanent marks and reference marks did not melt during the fires and remained generally intact and stable. The timber pegs marking property corners also remained intact although many were found burnt and in poor condition. In areas where there was little or no survey marks, volunteers were requested to locate the burnt remains of fencing as it provided the best evidence of where the boundaries were. It was quite common in the fire areas to find all that remained of a rural fence was the strands of wire on the ground and the holes where the posts used to be.

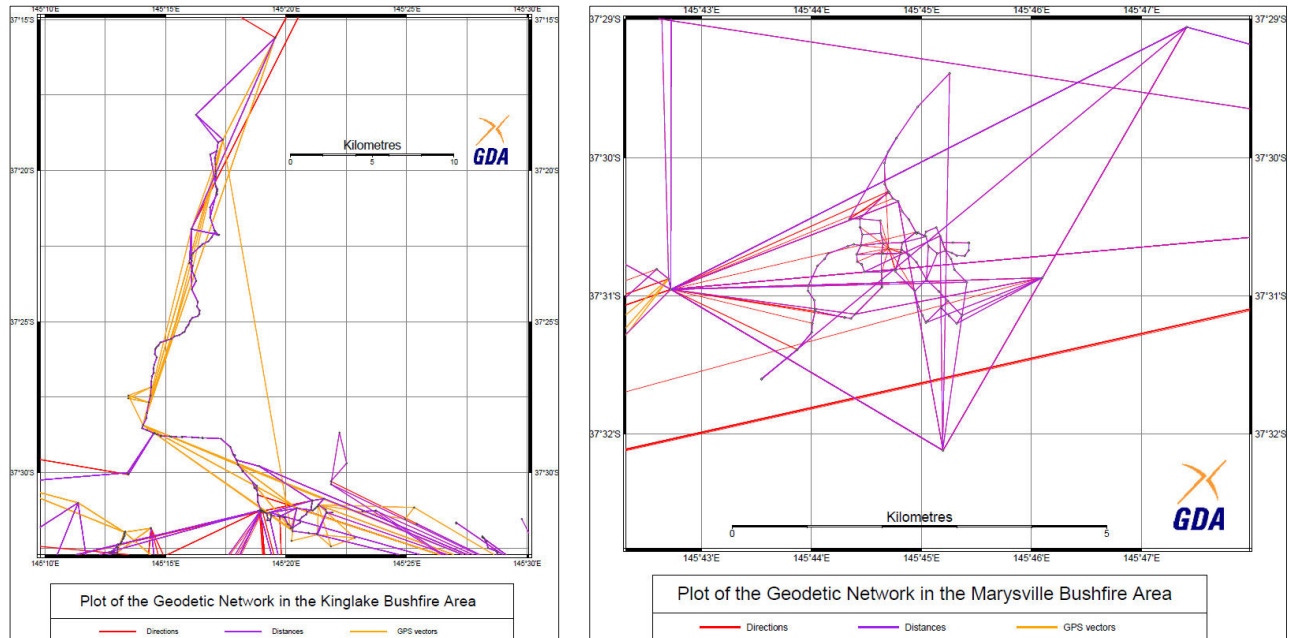
Figure 3 shows plots of the ground mark control networks in the vicinities of Kinglake and Marysville. Both networks were established in the 1970's by traversing with theodolite and EDM as part of the state's Survey Co-ordination Project. In the Kinglake region, due to the topography and vegetation, the traversing was restricted predominately to the major roads and the poor geometry resulted in some of the marks having positional uncertainties of ± 0.3 metres. 50 of the 65 coordinated permanent marks in this region were recovered and further marks were established and additional GNSS vectors observed to densify and strengthen the network. This improved the positional uncertainties to better than 0.08 metres.

In Marysville, as the network was more compact and had been established with better geometry, the positional uncertainties of the permanent marks were better than 0.05 metres with the majority in the order of ± 0.02 metres. 44 out of 61 coordinated permanent marks were found surviving and subsequently deemed to be adequate as control for the township.

Figure 3. Permanent mark control networks at Kinglake and Marysville.

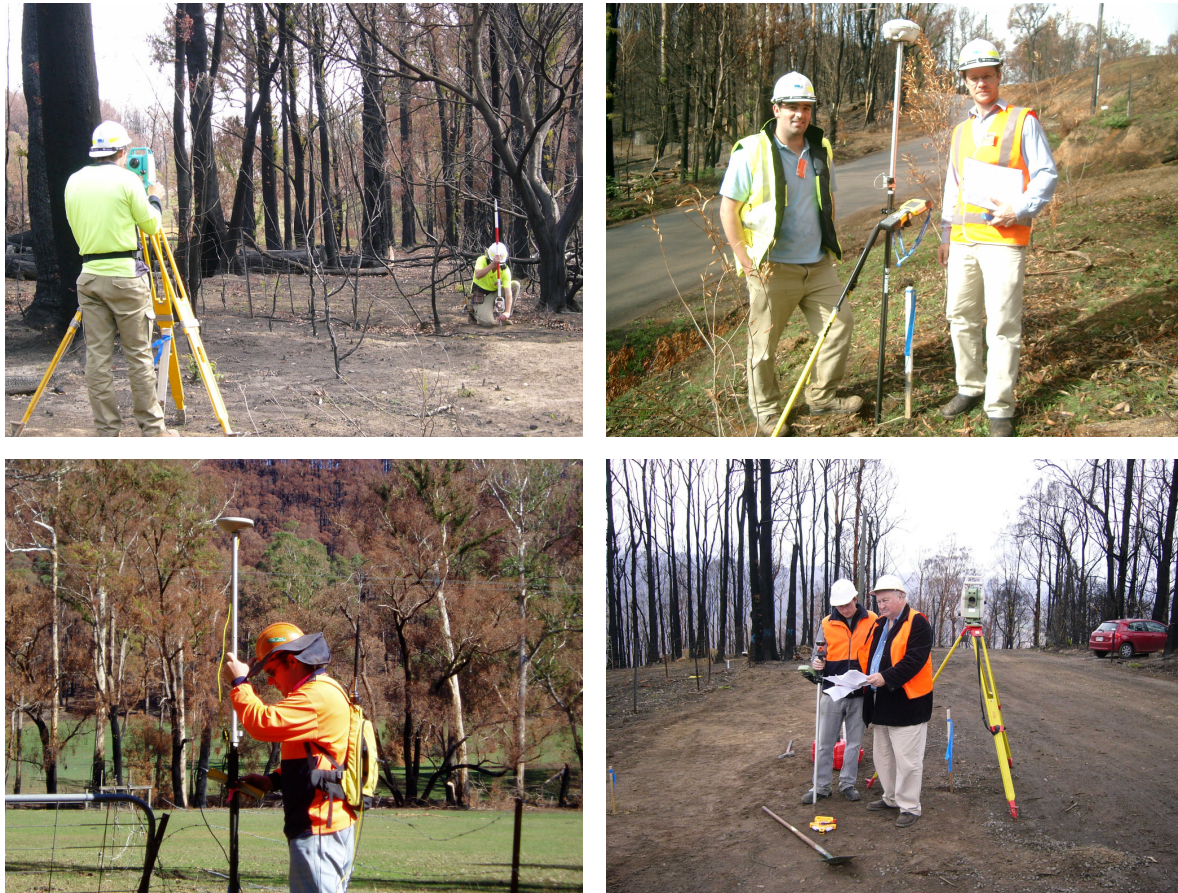
Figure 6 is a collection of photos of the volunteer surveyors at work in and around Kinglake. A combination of electronic angle and distance measurements via Total Stations and position measurements using single rover GNSS receivers were used by the volunteers for determining the positions of the survey marks found. Regardless of the equipment used, the requirement was for all the surveys to be related to the one datum, namely the Map Grid of Australia 1994. This was achieved via connection to the coordinated permanent mark network or the GNSS reference stations that had been established earlier to cover the work areas.

Figure 6. Volunteer Surveyors at work in the Kinglake Region
