**Early Production System (EPS)**  
**Barge Movement and Installation at**  
**Olero Creek Production Platform,**  
**Benin River Area.**

Sylvester Efe OWHOJETA, Nigeria

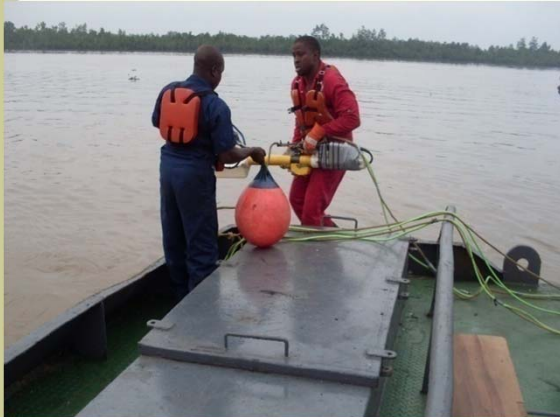
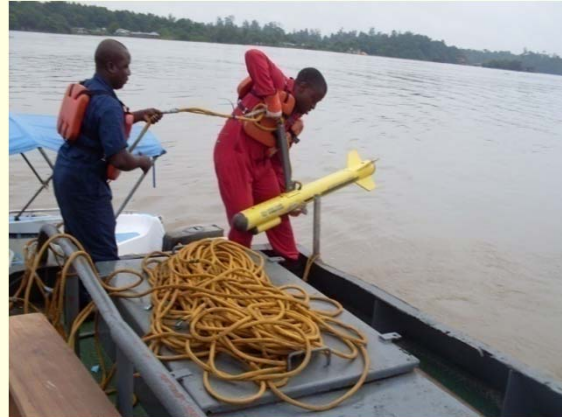
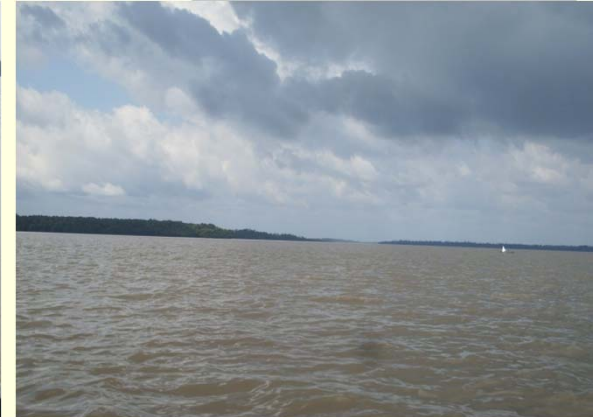
Deployment of Underwater Sensors in preparation for Channel Check

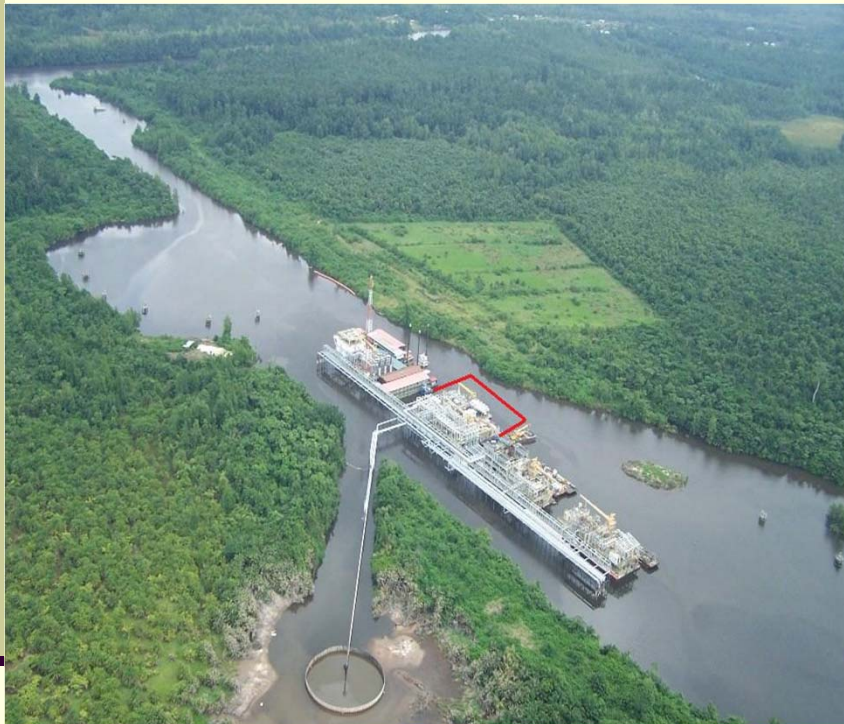
EPS barge site layout marked Red

Pre-survey of the site was carried out which required topographic and bathymetric appraisal of the entire production platform area. This information was used to reappraise the setting out of the EPS barge location before sand padding, evaluate the sand pad height and quantity of sand required. The area set-out was 60m by 30m (1,800 square metres).

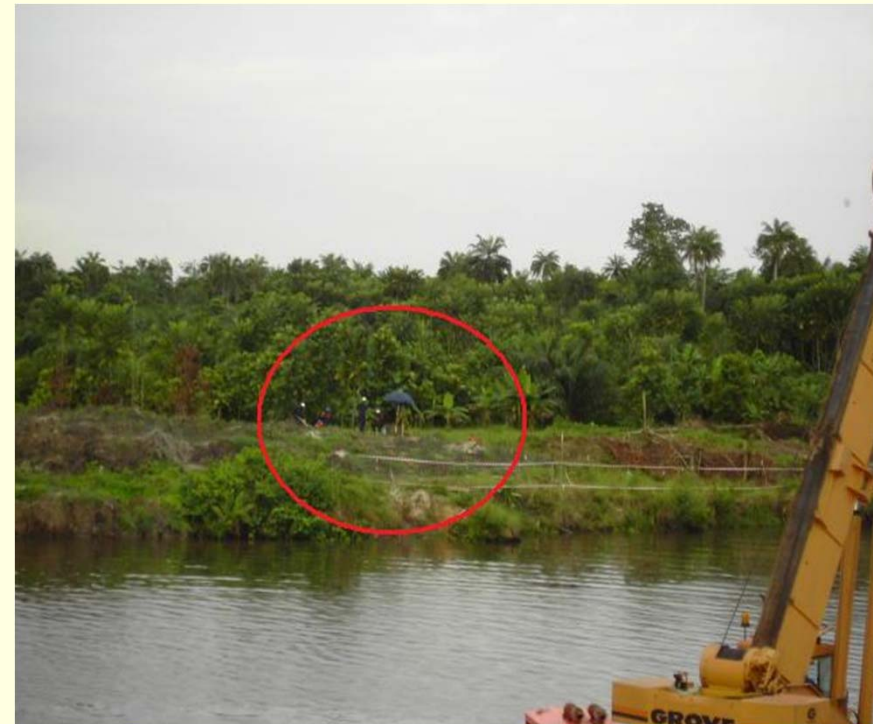
Survey crew on site during EPS site layout setting out and preparation.

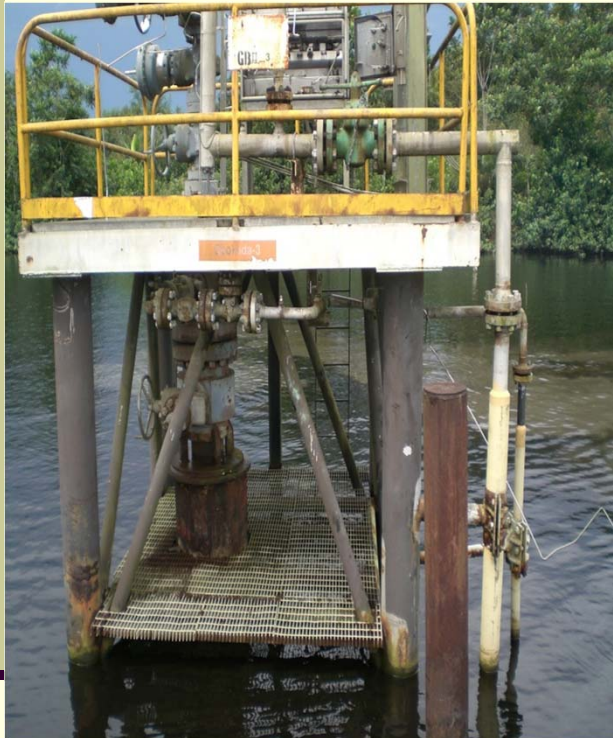
Olero GB-3 location with the 1m mark.

Datum adopted for channel check was Lowest Astronomical Tide (LAT) as charted on the tide table, while the 1m mark reference datum at GB-3 location, Olero Creek was used for the project and tagged project datum. There was continuous tide monitoring to determine the nature and water behaviour.

The datum adopted and used for the project is the 1m mark reference datum at GB-3 Location, Olero Creek, Benin River area. The tide gauge established on site for tide monitoring was based on the 1m mark low low water spring (LLWS).

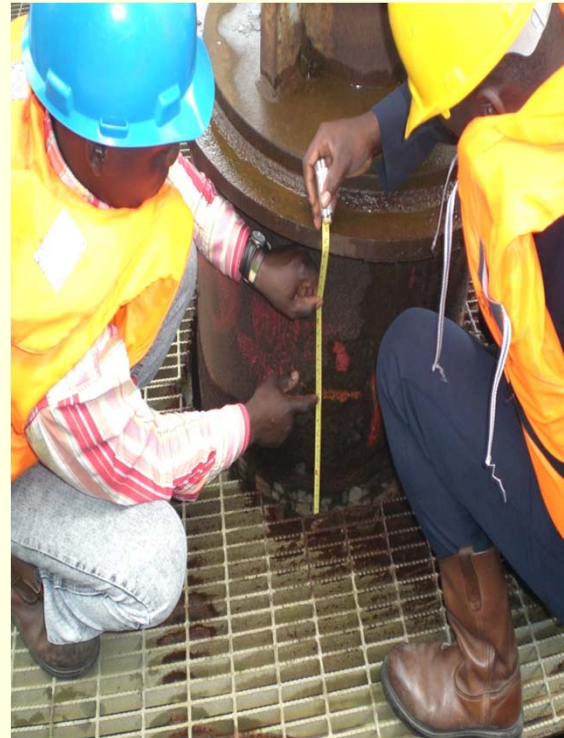
Check on the 1m mark at GB-3 location.

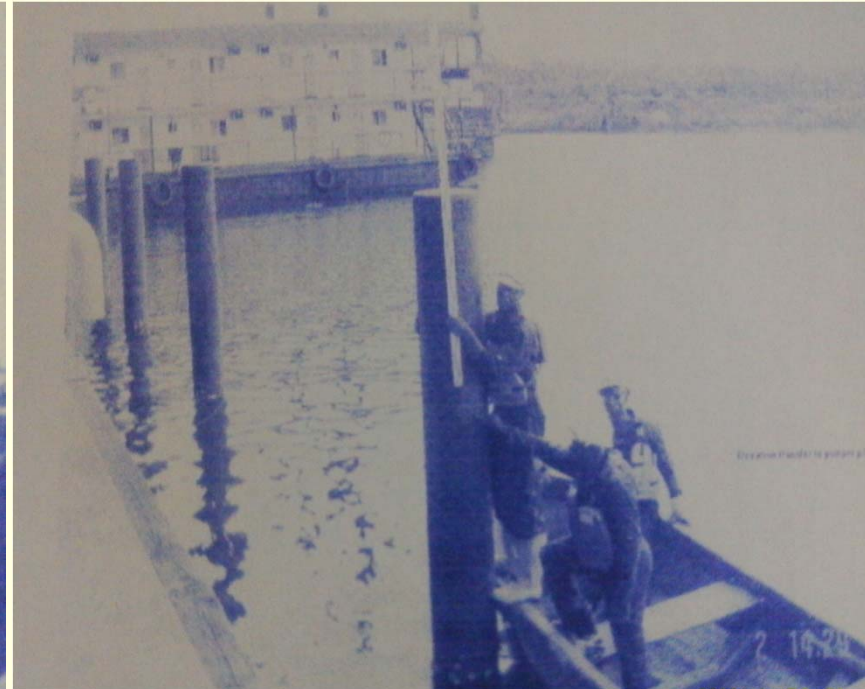
EPS sand padding process and height determination on site

**Note:** Sand padding on site was achieved by dropping and spreading of sand at the laid out area by the use of wheel excavator mounted on a barge.

Sand padding on site was achieved by dropping and spreading of sand at the laid out area by the use of wheel excavator mounted on a barge. The padding was designed to accommodate the overlap including loses, and was closely monitored by the survey crew to ensure compliance to specification. Final pad level below datum was 2.15m, hence the constructed pad height was 0.95m (that is, 3.1m – 2.15m = 0.95m).

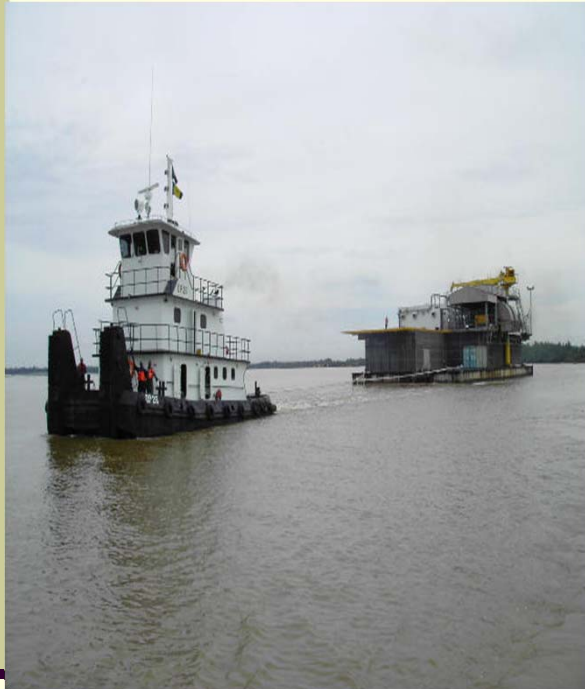
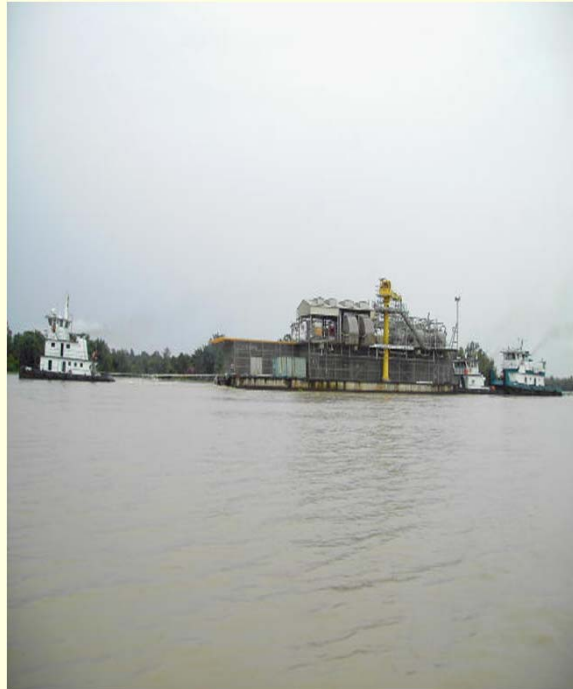
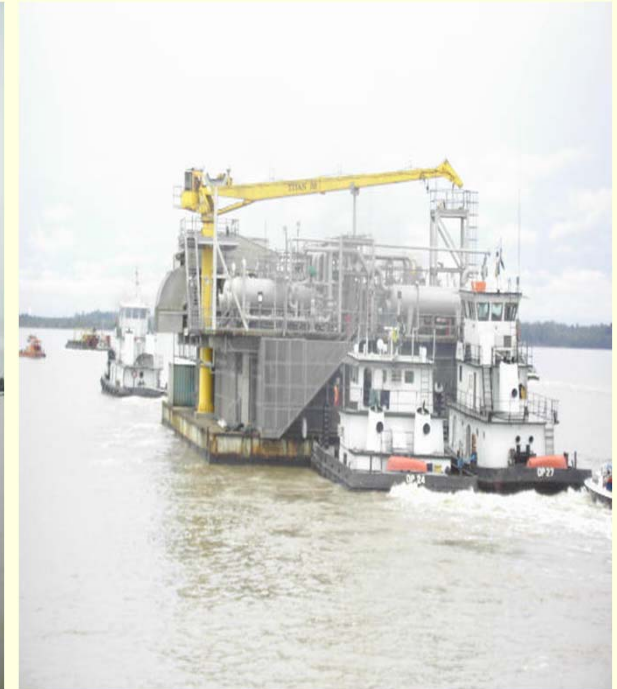
EPS barge tow to location at Olero Creek powered by 4 tug boats, assisted by Community chase boats and GSF

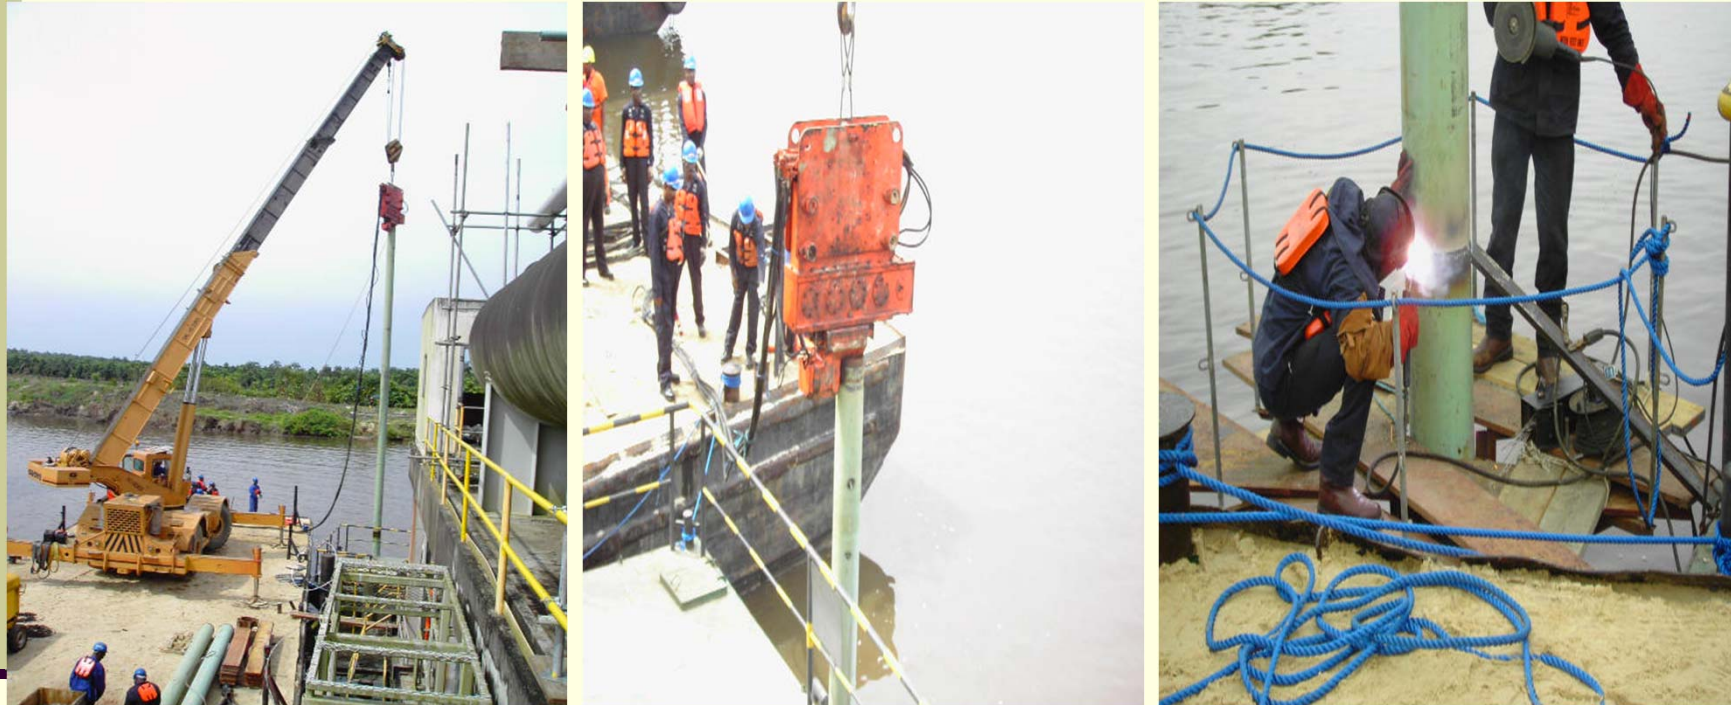
Installation of 16nos 12" double length Piles using vibro pile hamper and Welding work at the EPS barge location

Piling of the 16nos 12” double length piles (restraining, guide and bumper) was achieved on site using vibrating (vibro) hammer mounted on a mobile crane, under the guidance of the Surveyors to ensure alignment and verticality until cut off point. The guide and restraining piles were installed at opposite end of the barge, while the bumper piles were installed along the barge. All cut off points were marked and established.

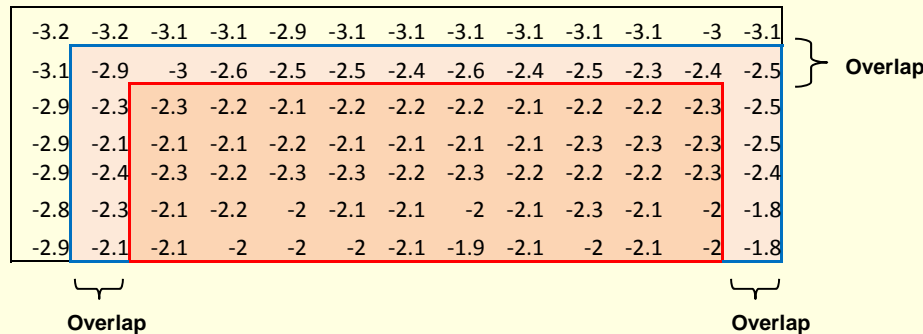
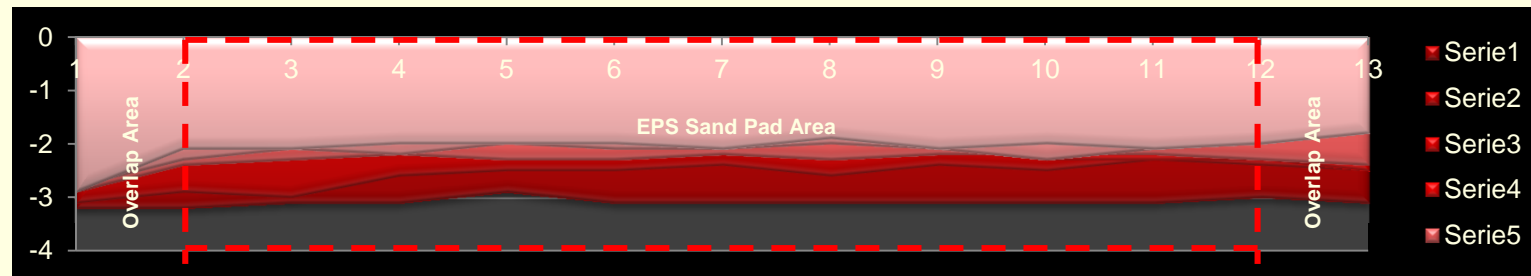
The sketch and graph below show the final EPS sand pad and depth monitoring on location.

- Dredging Depth = 3.1+/-0.15m LLWS (Given)
- Sand Pad Height (Thickness) = 0.80m (Given)
- Expected Water Depth = 2.30m

Depth monitoring of the laid out area was carried out at 5m interval to cover the sand pad and overlap. This was achieved by continuous bathymetric appraisal as padding progressed.

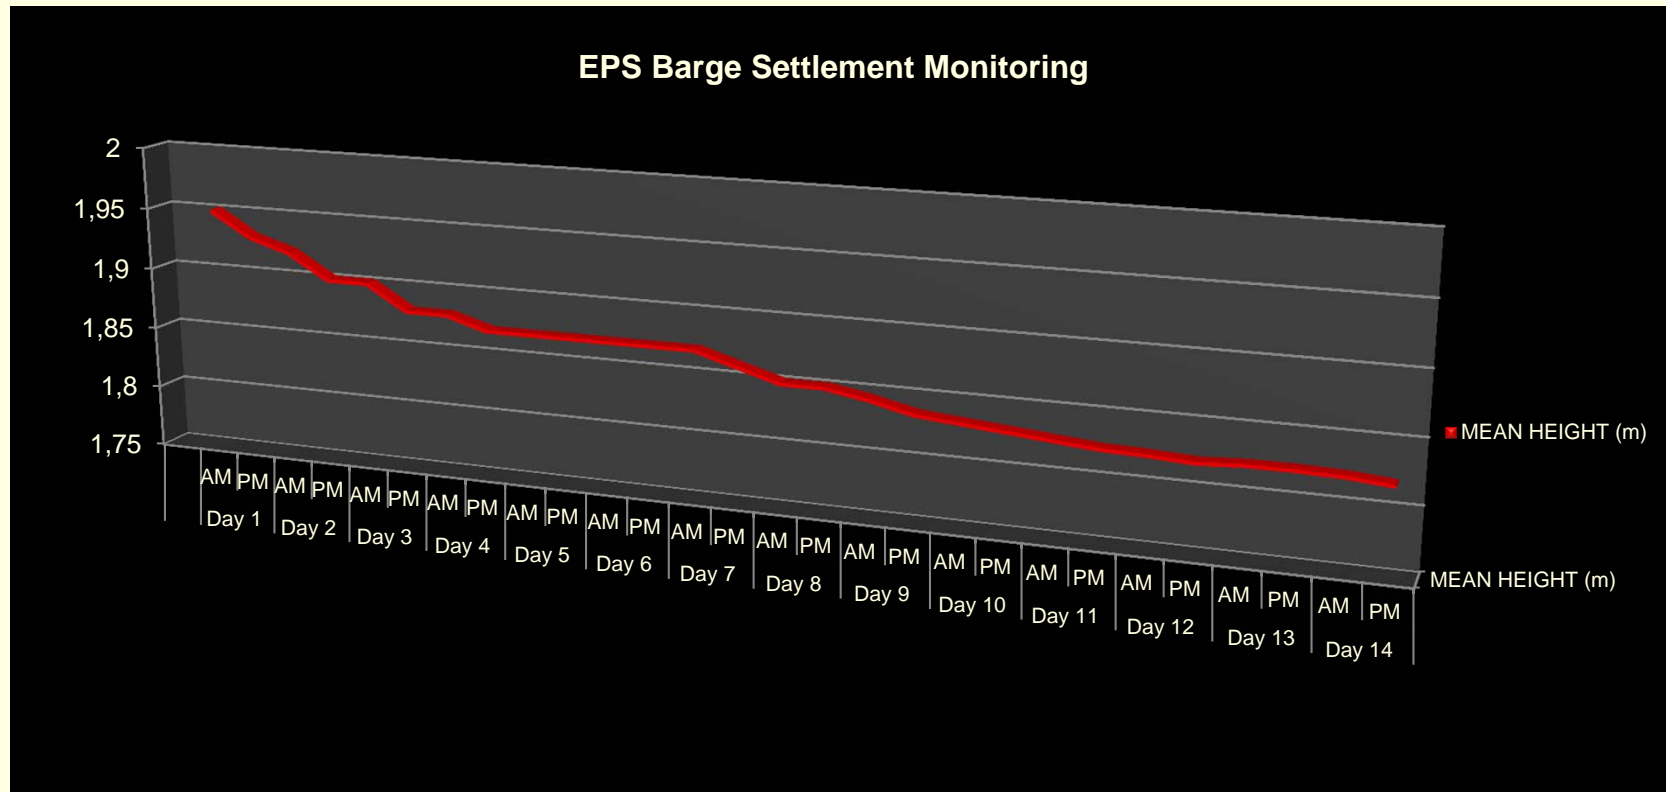
The graph shows the EPS Barge Settlement Monitoring Trend on Location

Monitoring of the EPS barge settlement was carried out morning and evening for four weeks to ascertain height conformity with specification.
