# Christchurch Earthquakes

***Innovation from Disaster***

FIG Working Week 2016

# ***SITE CALIBRATION – COMBINED GEOID MODEL & INCLINED PLANE***

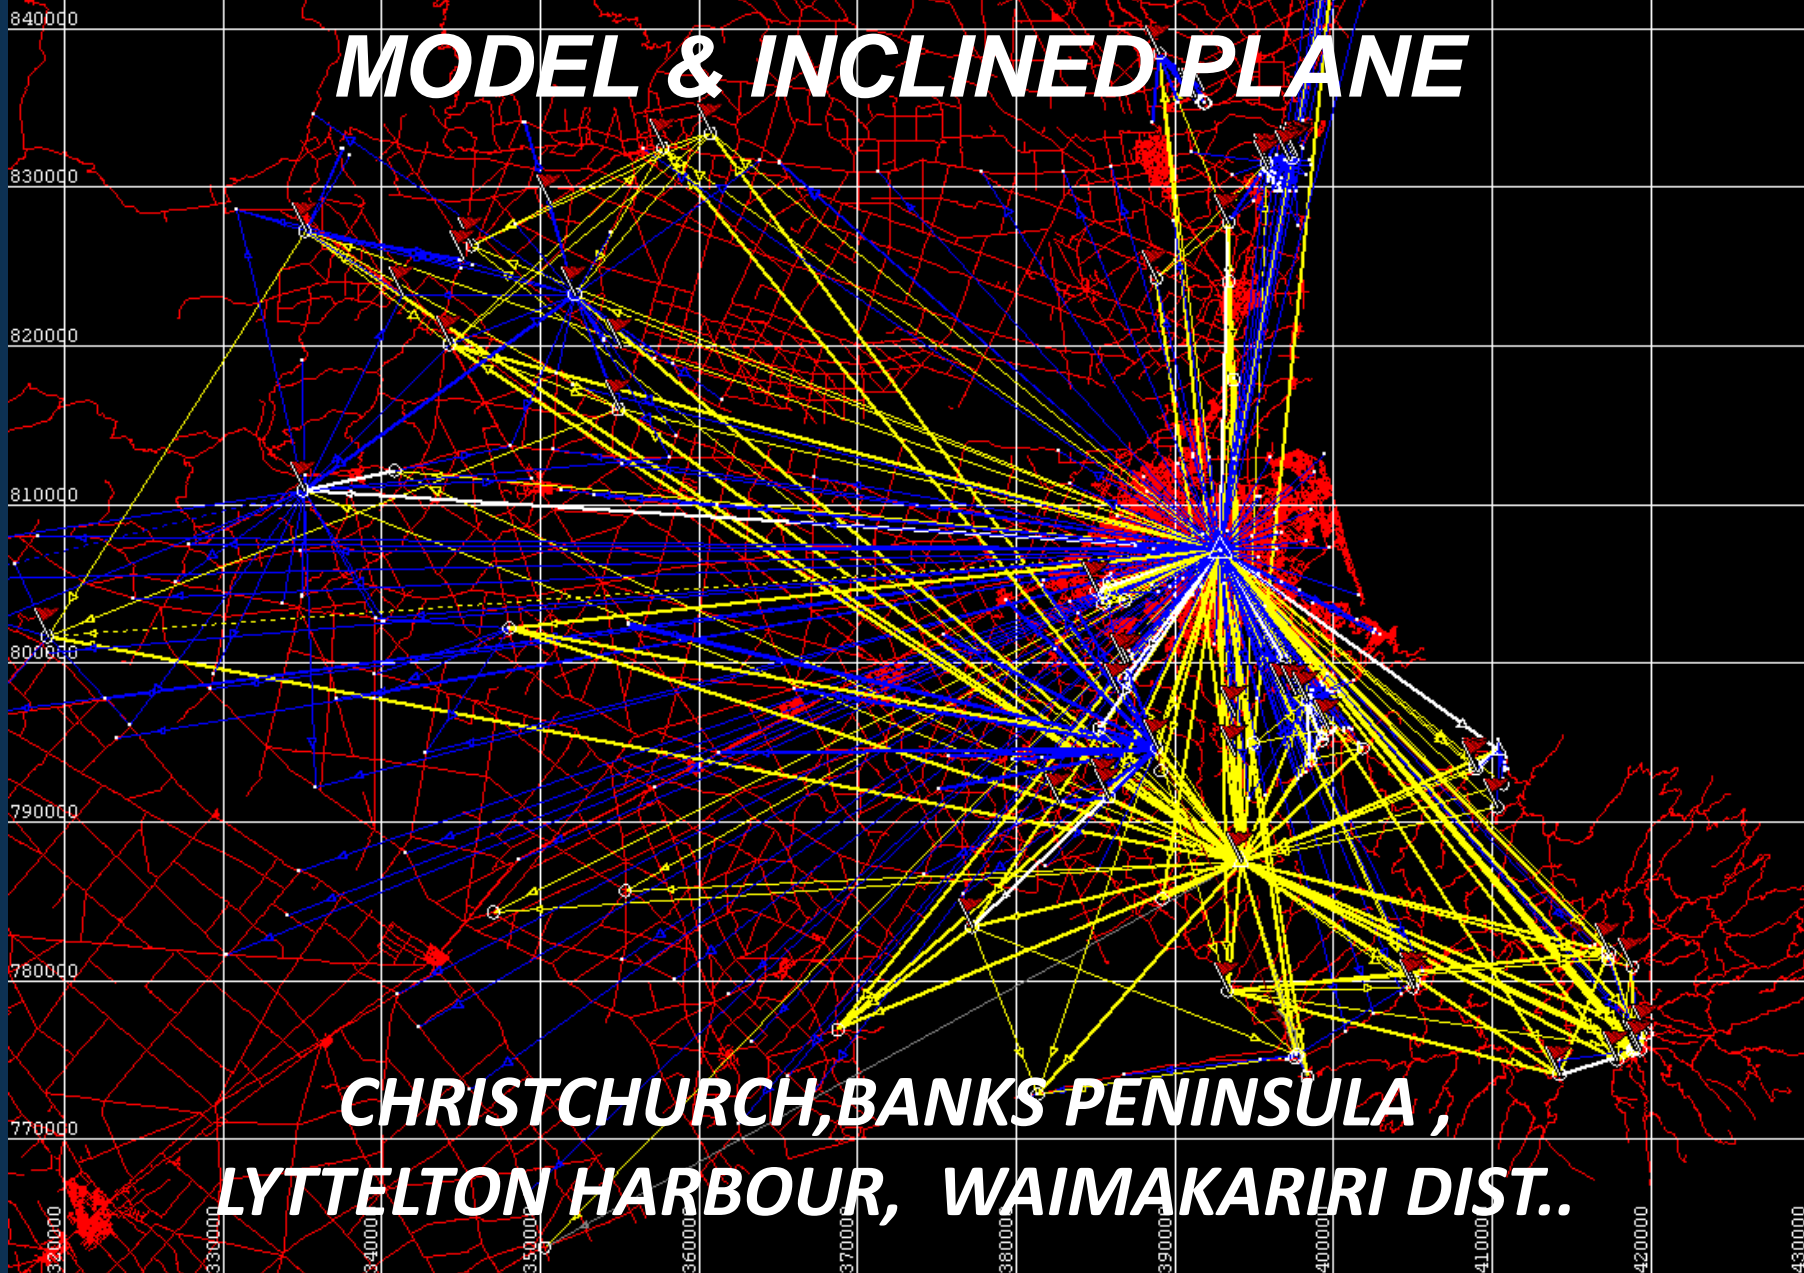
***CHRISTCHURCH, BANKS PENINSULA,  
LYTTELTON HARBOUR, WAIMAKARIRI DIST..***

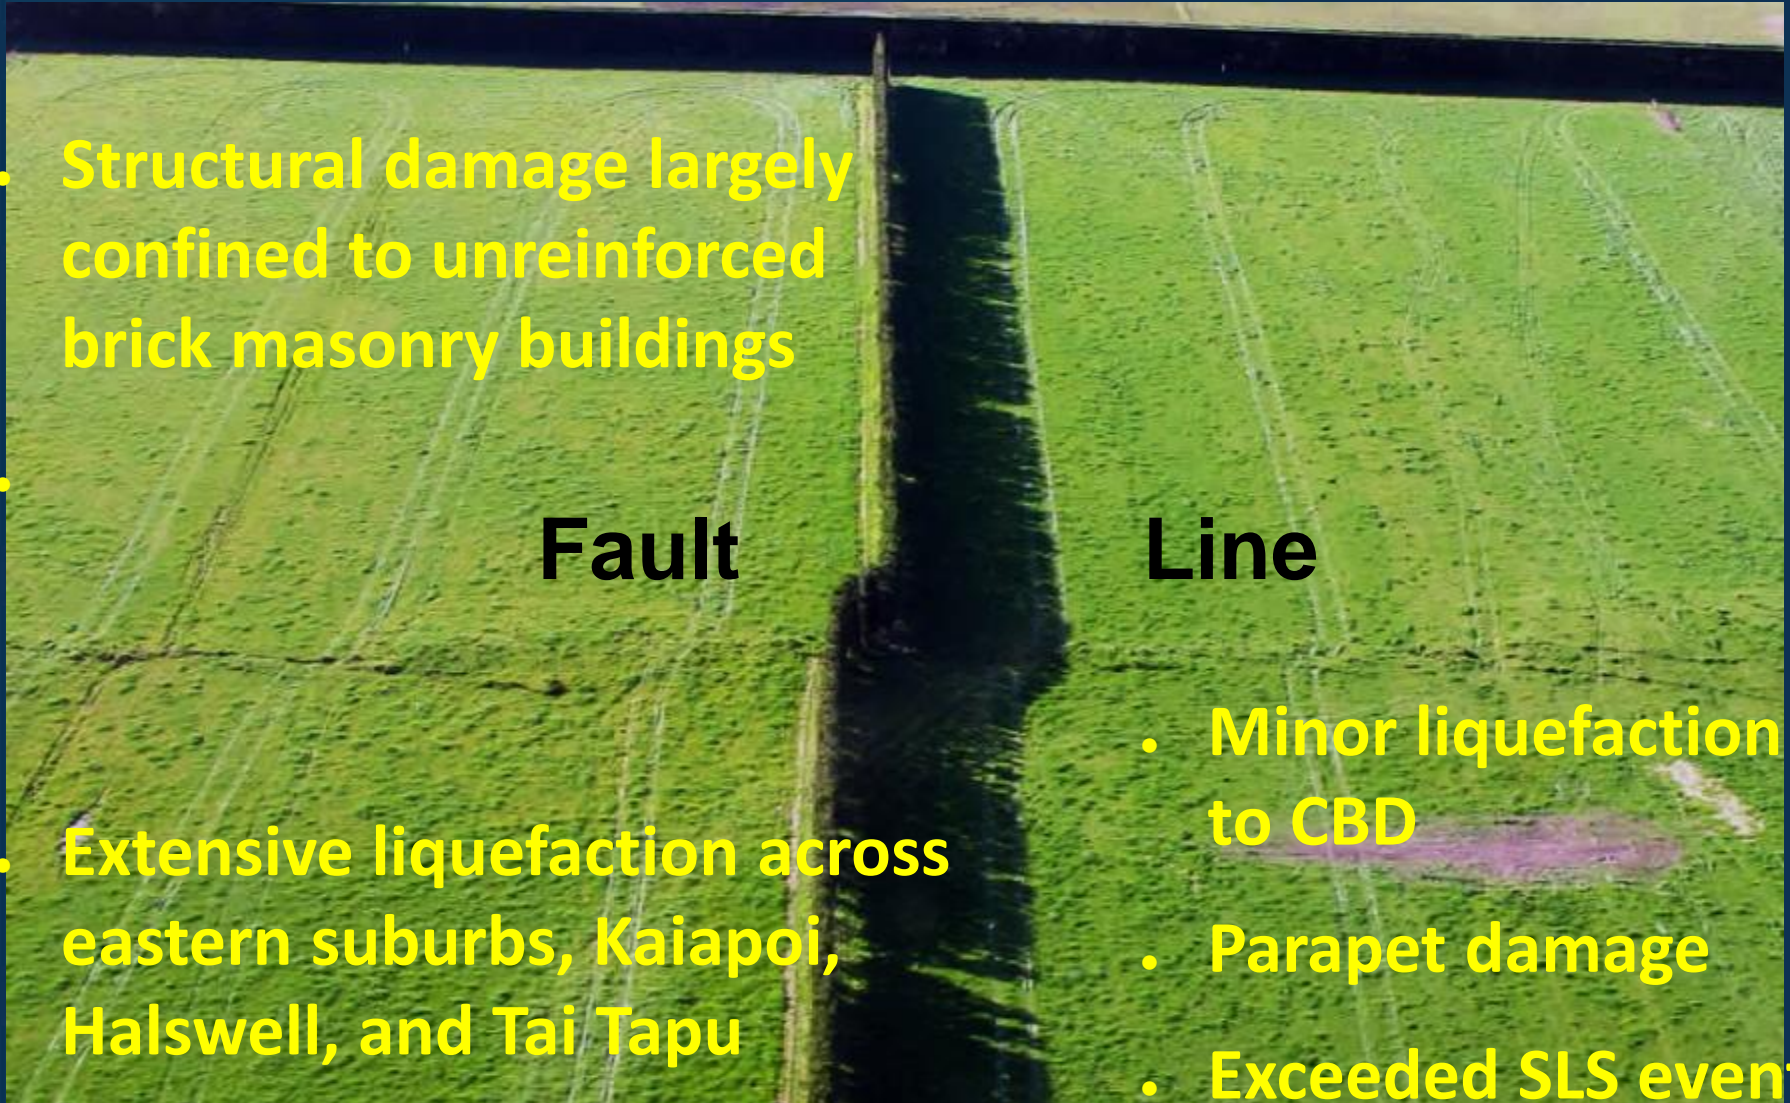
# 4 September 2010 Earthquake

- Structural damage largely confined to unreinforced brick masonry buildings

- Extensive liquefaction across eastern suburbs, Kaiapoi, Halswell, and Tai Tapu

- Minor liquefaction to CBD
- Parapet damage
- Exceeded SLS event

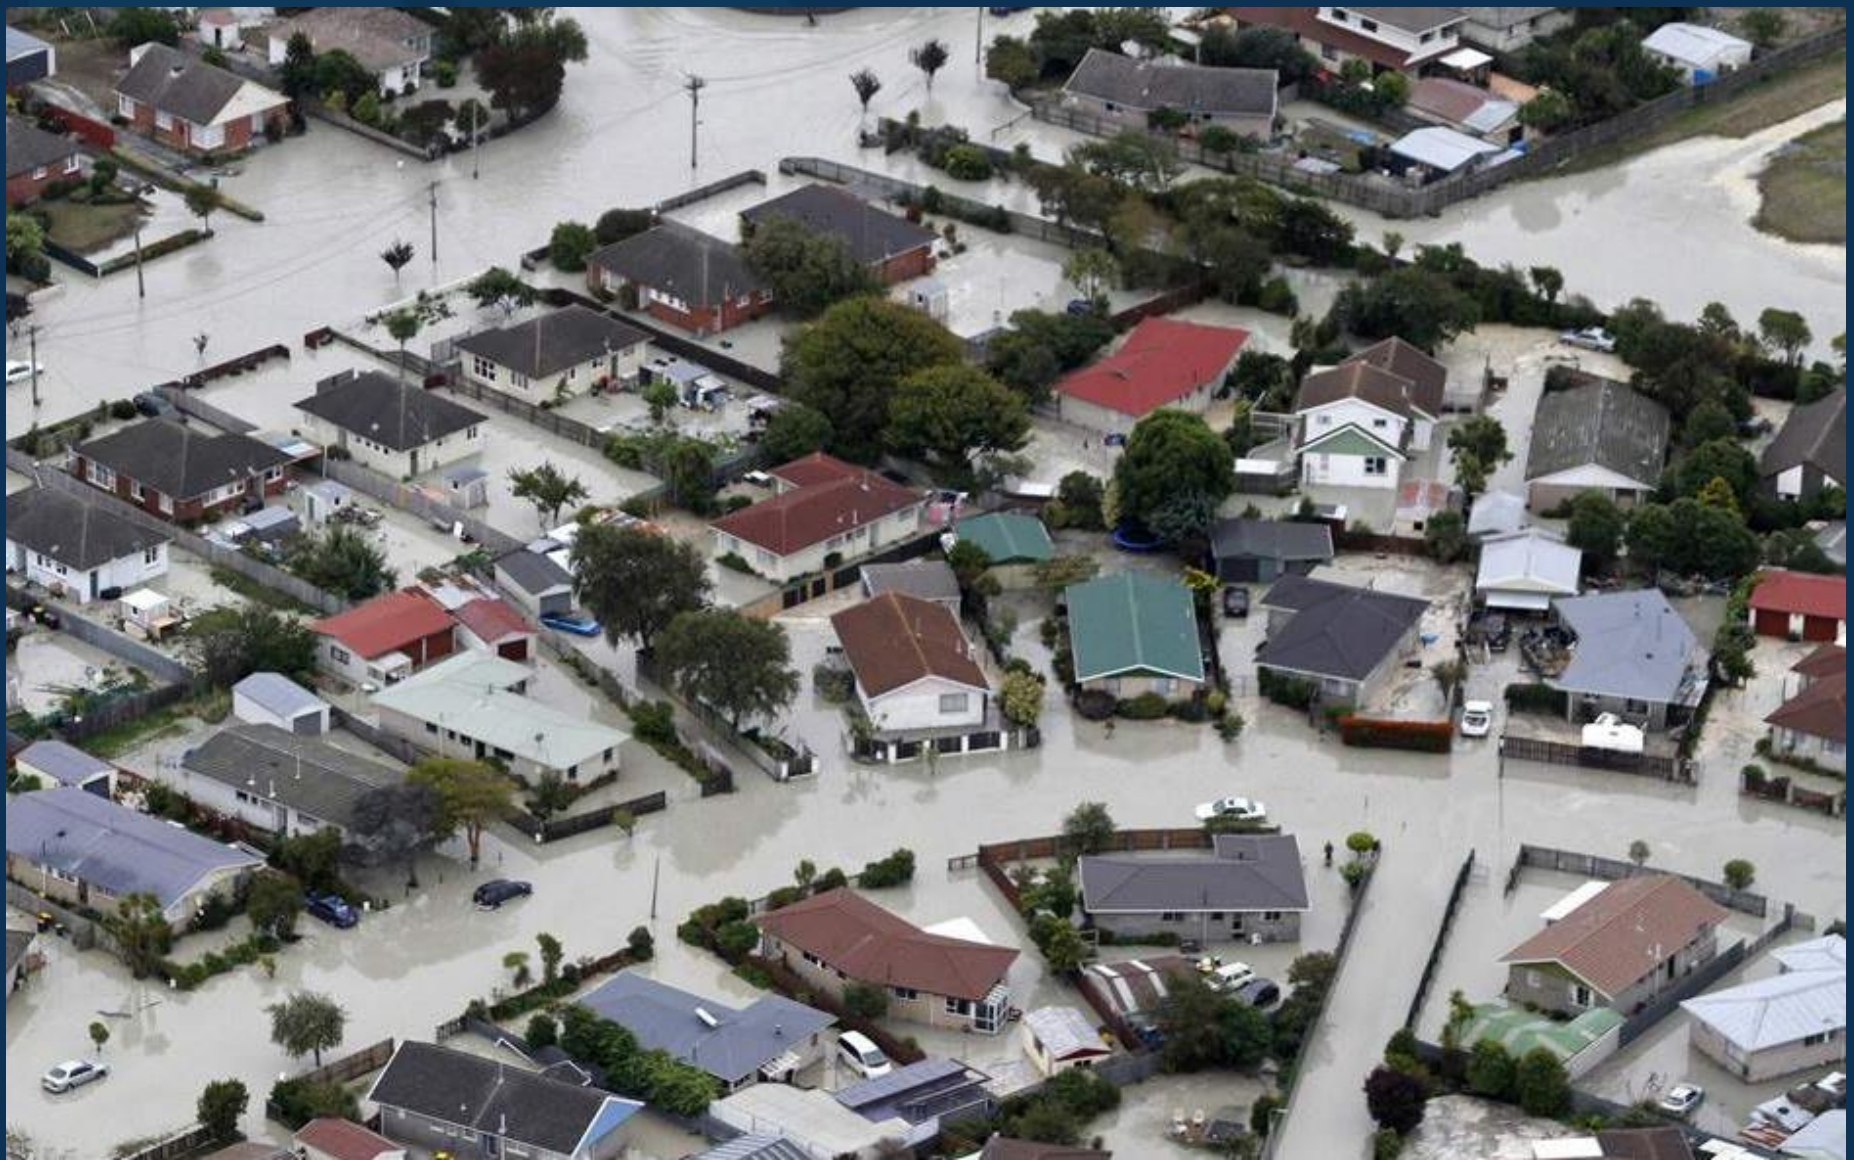
# Christchurch Earthquake - Liquefaction

Flooding & Subsidence from  
liquifaction everytime a big shake

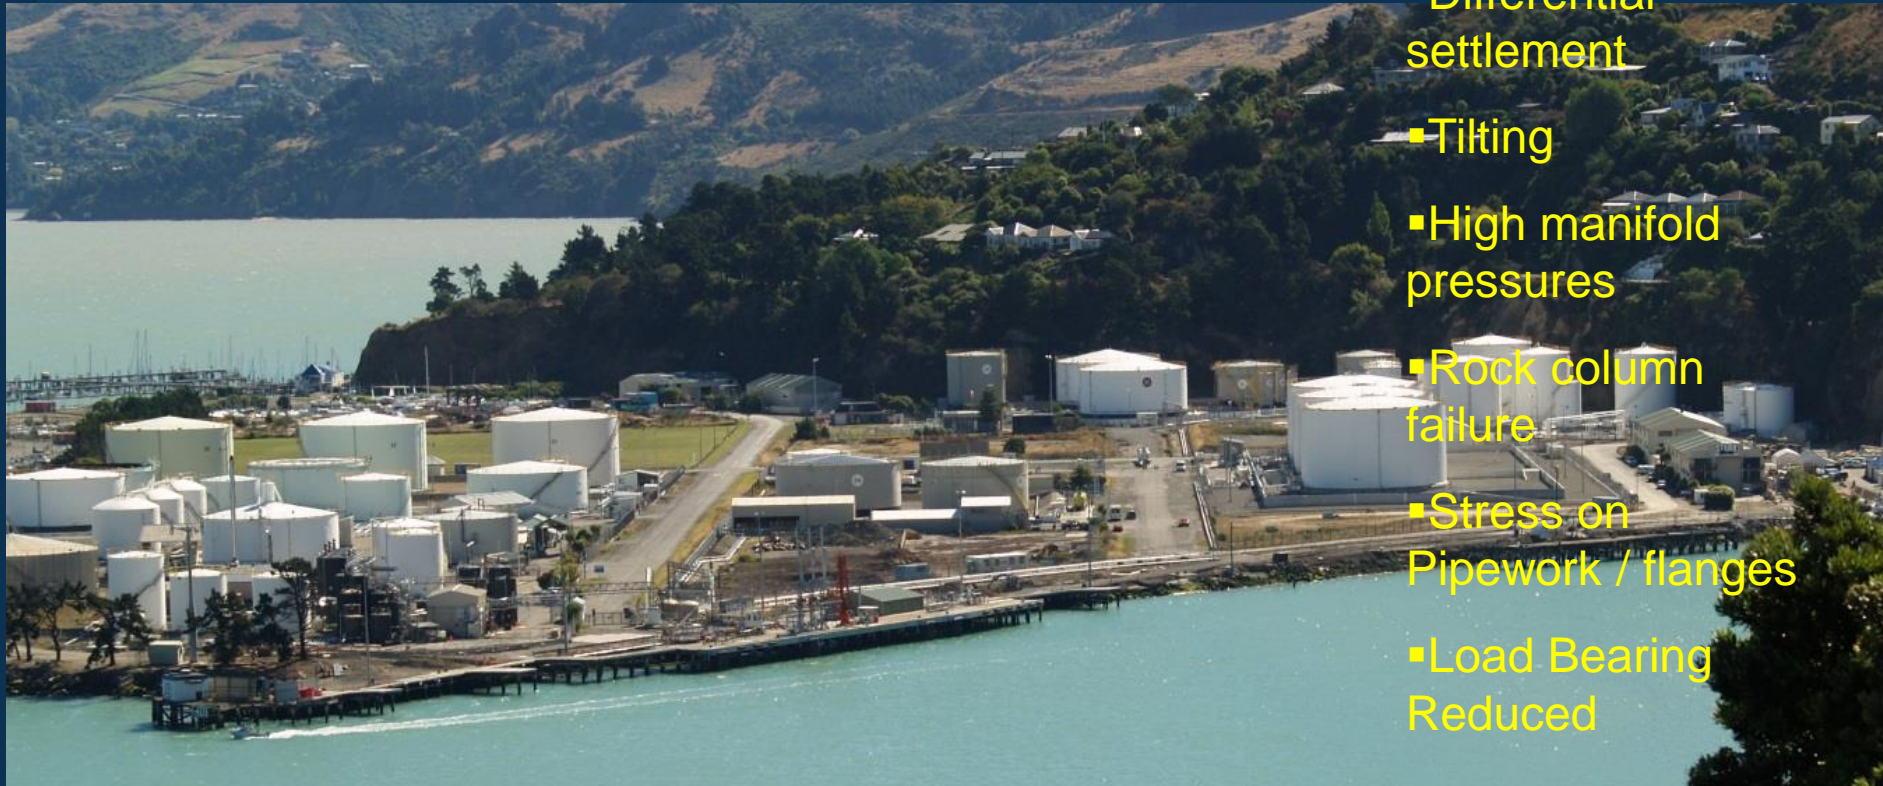
# Intense monitoring of Tank Farm & Wharf

- Differential settlement
- Tilting
- High manifold pressures
- Rock column failure
- Stress on Pipework / flanges
- Load Bearing Reduced

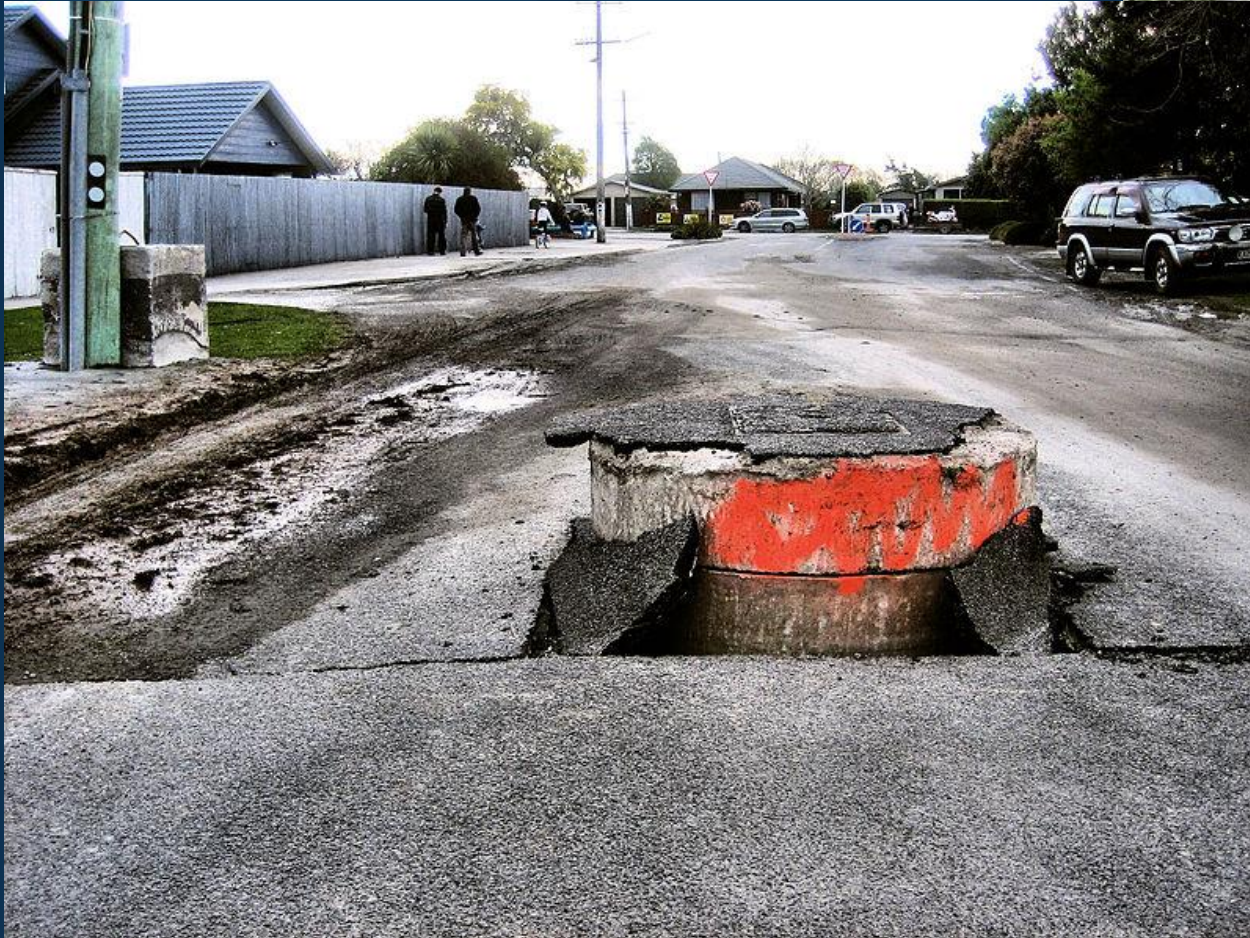
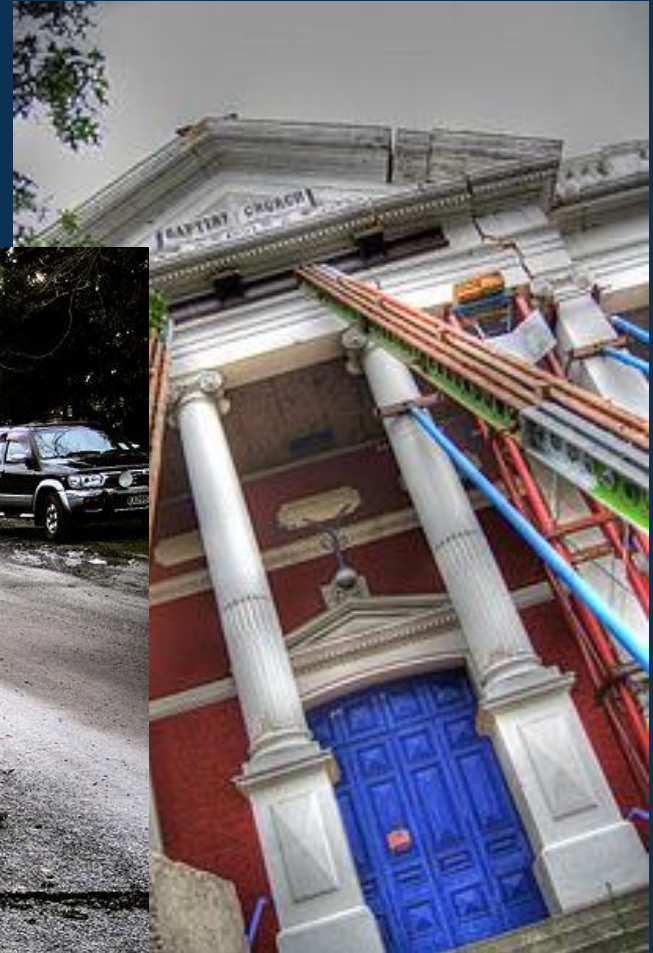
# Horizontal Infrastructure

*Surface and  
Underground services  
failed*

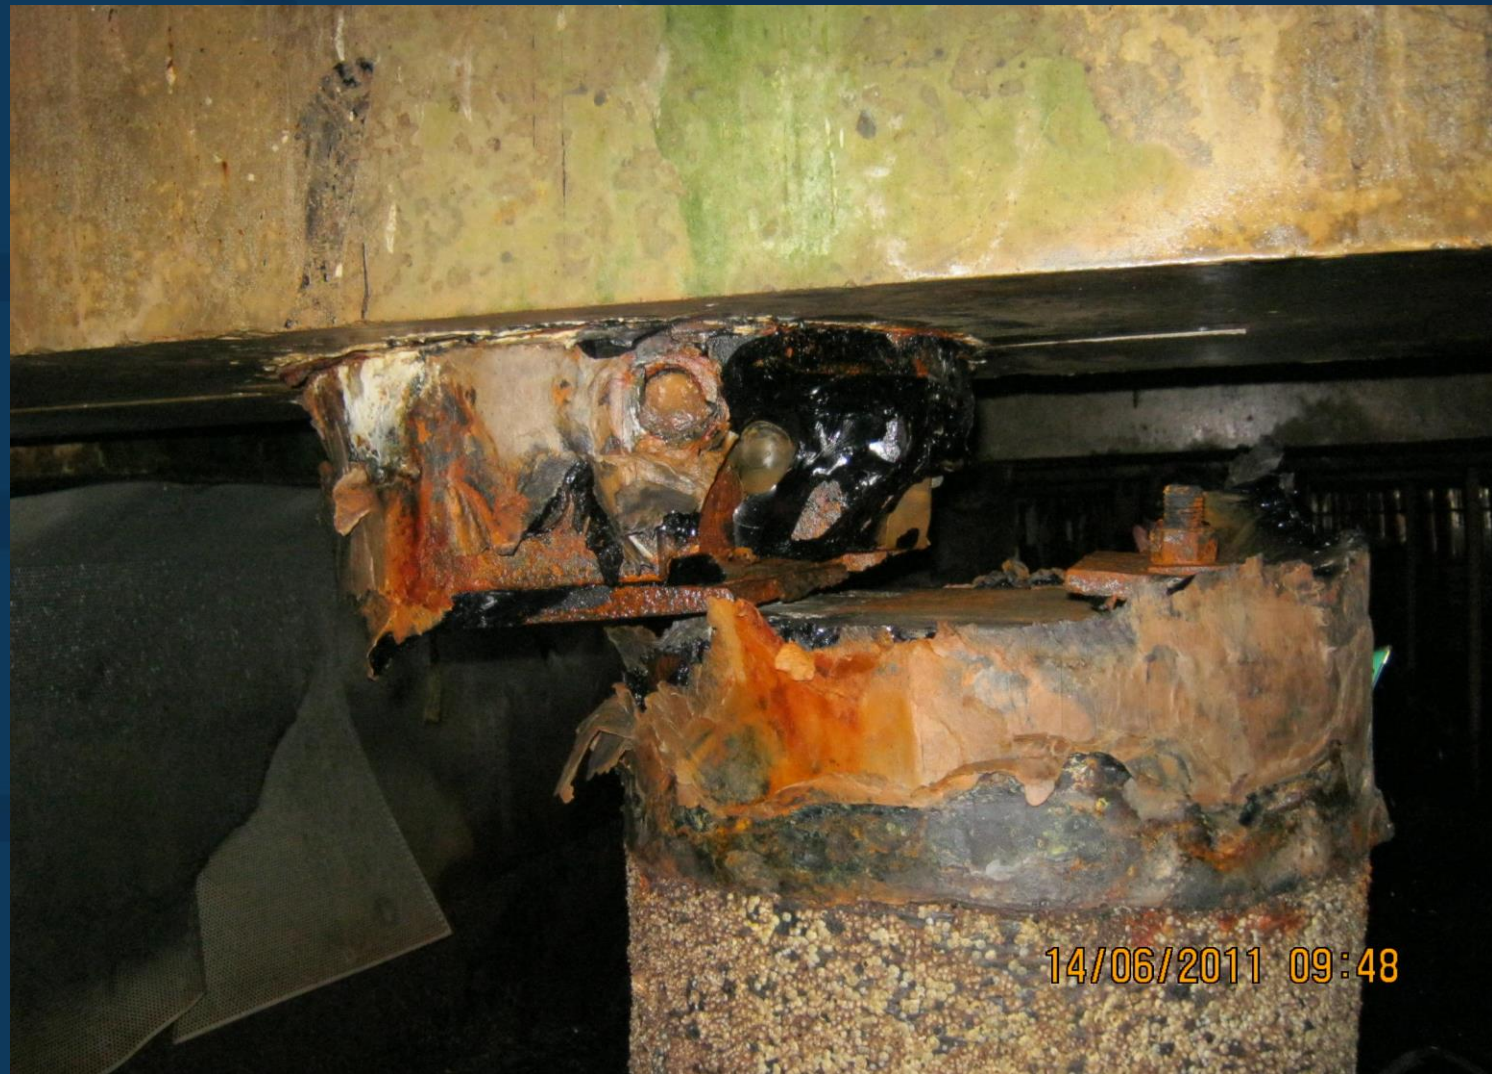
Lateral forces from the hardstand push  
the decking seaward

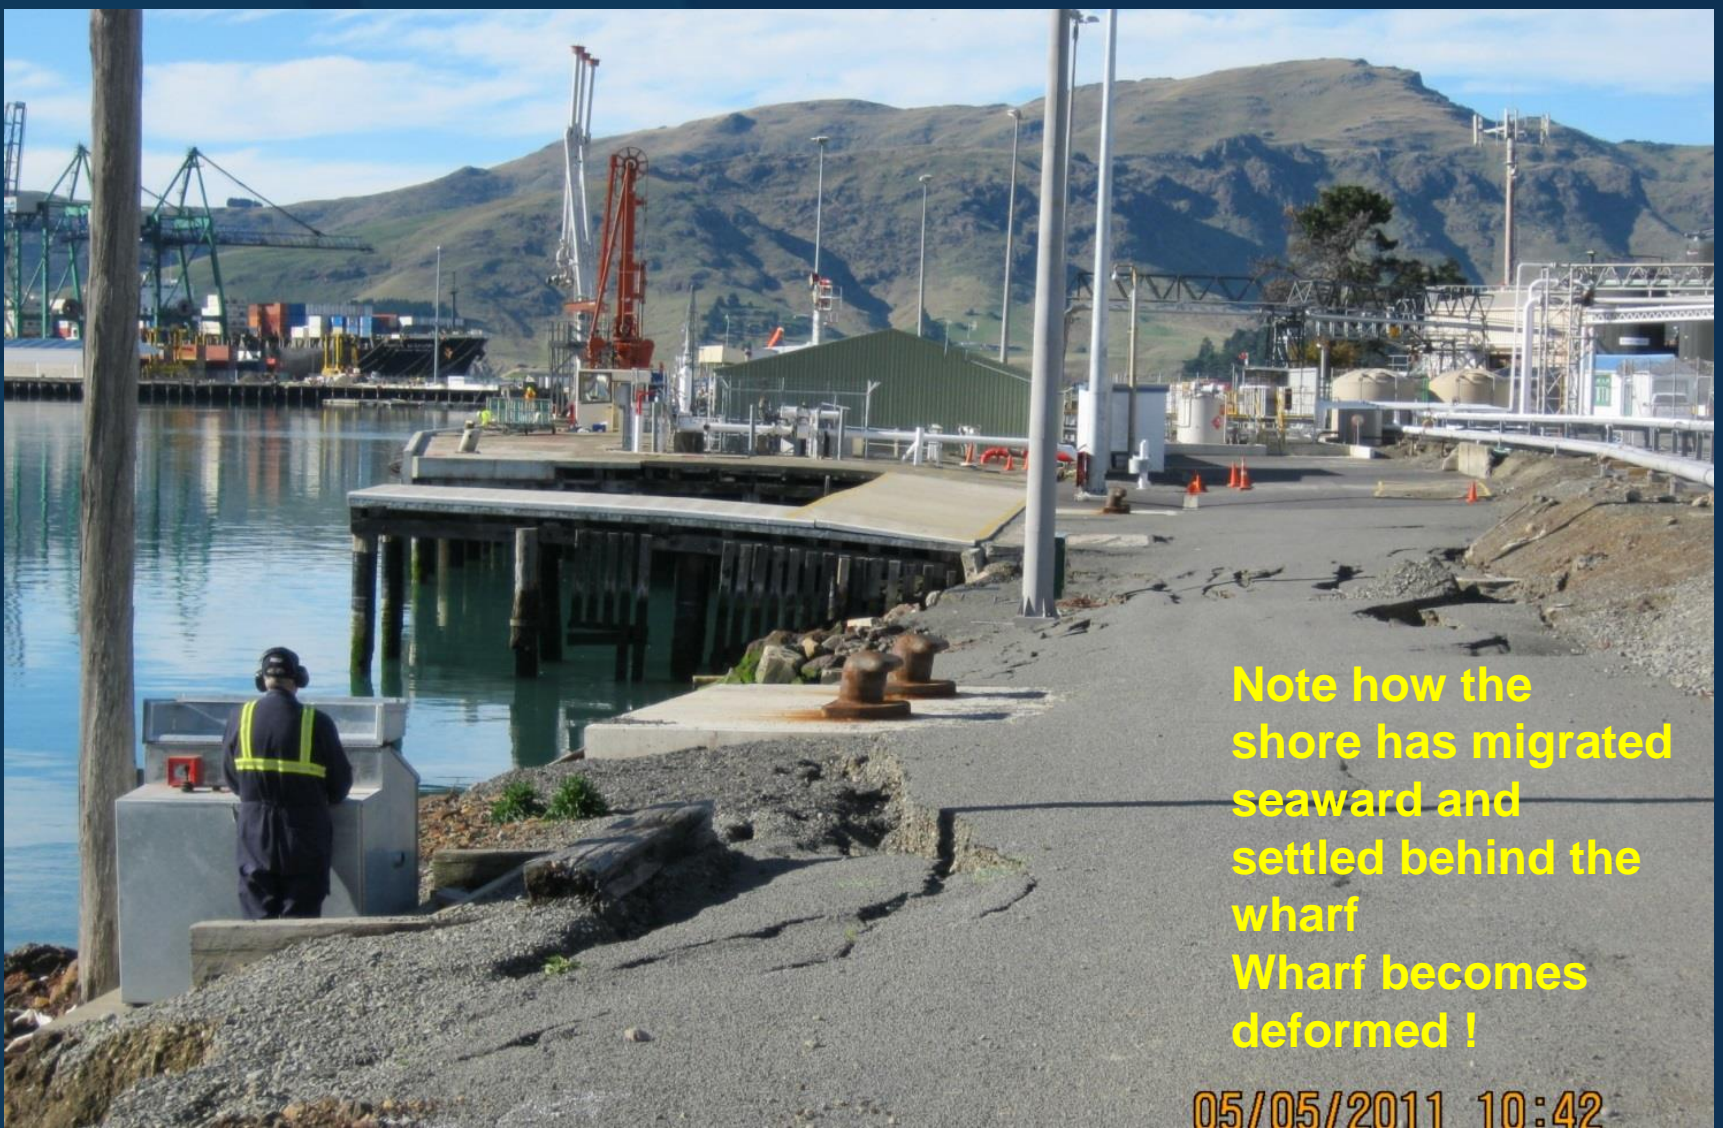
## Oil Wharf - Lyttelton

Note how the shore has migrated seaward and settled behind the wharf  
Wharf becomes deformed !

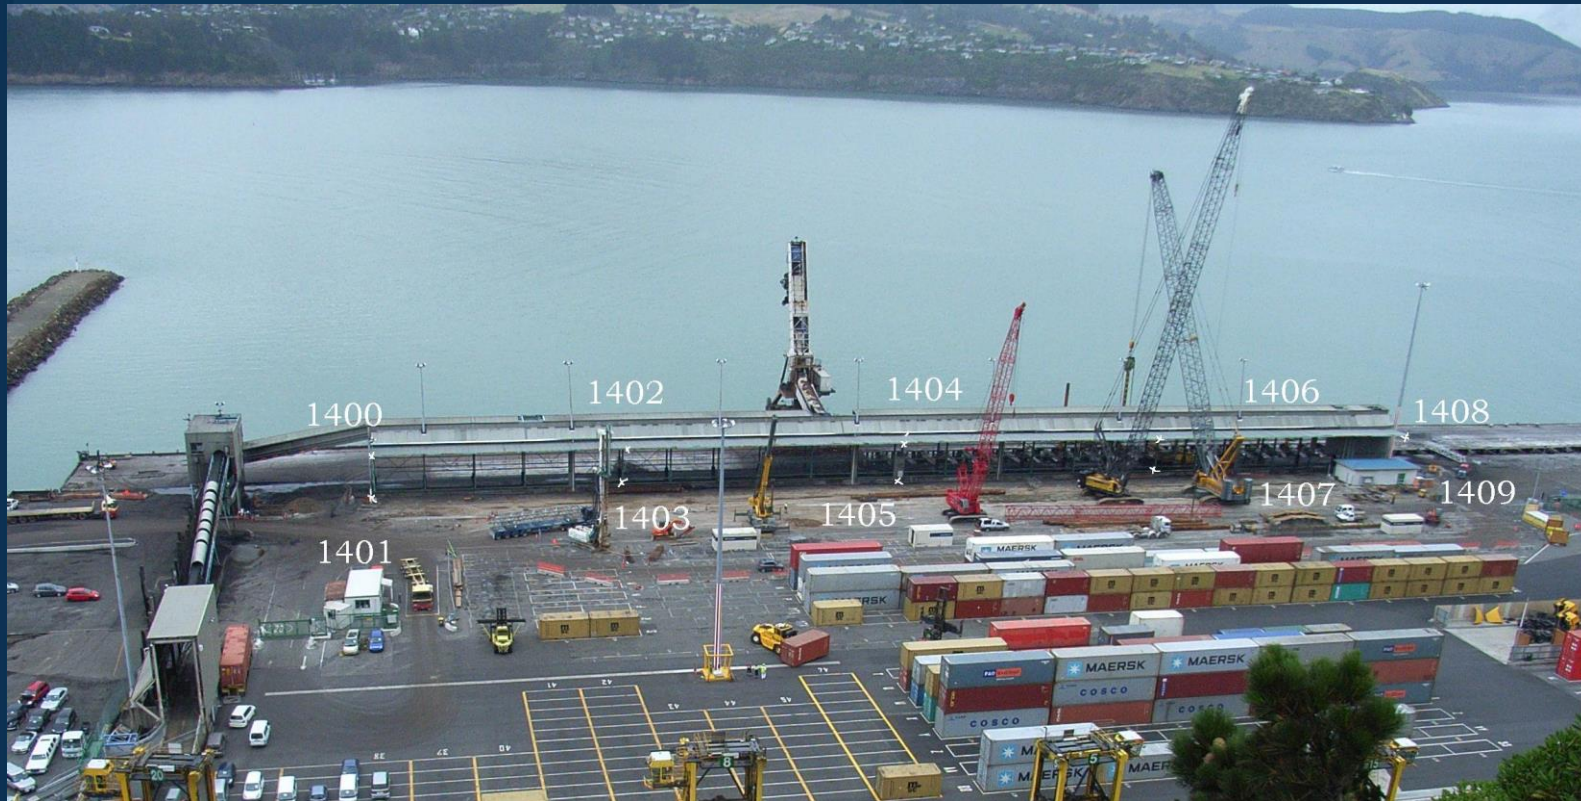
# Reconstruction Monitoring Cashin Quay

- Daylight surveys
- 15 Minute Cycle
- Real-time Reporting
- Crucial during Construction
- Remote & stable Reference Marks
- Hierarchy of Offset lines

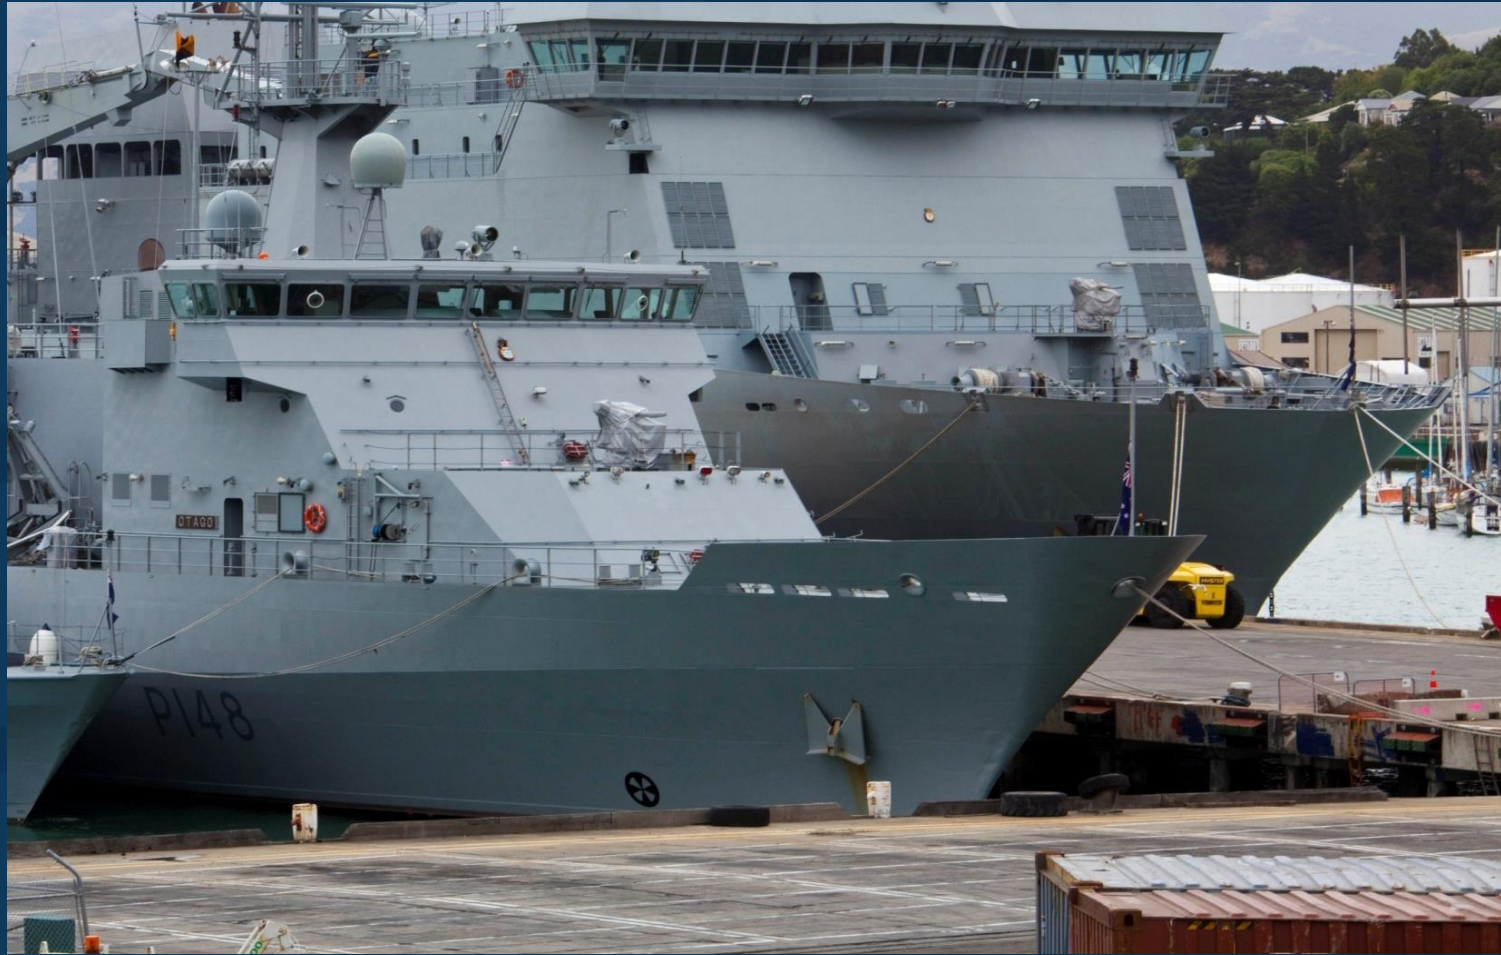
No. 7 Wharf- Seismic Isolation Joint  
Provided RORO functionality

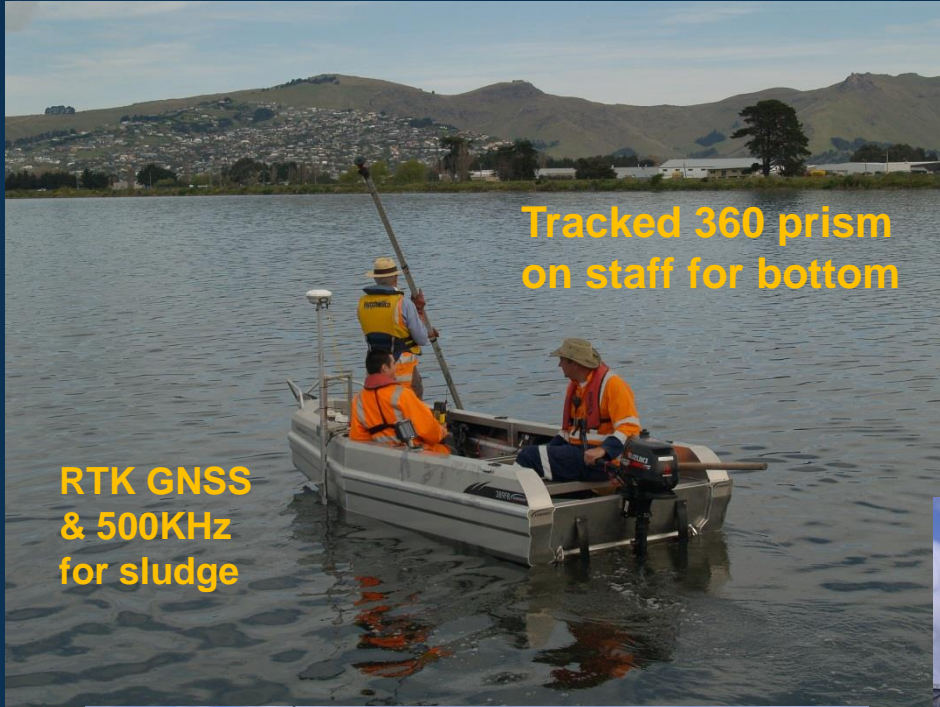
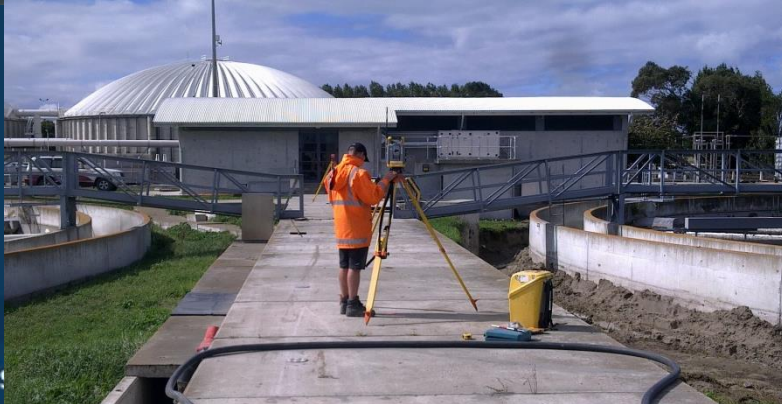
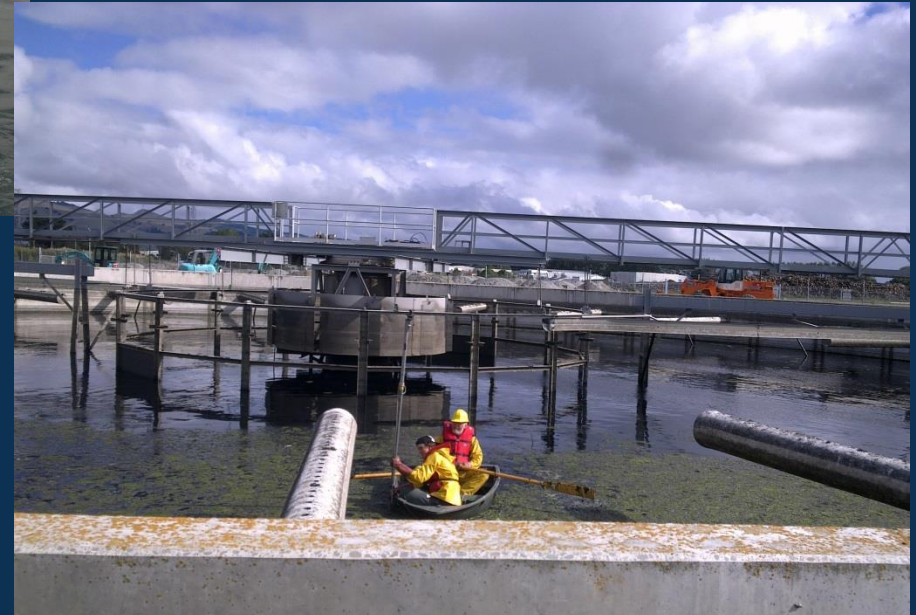
# Sewage treatment Plant

- Liquifaction (shallowing)
- Raw Sewage into Ponds (Loss of Volume)
- Clarifiers suffered mechanical failure and uplift
- Profiles & contours showed differences

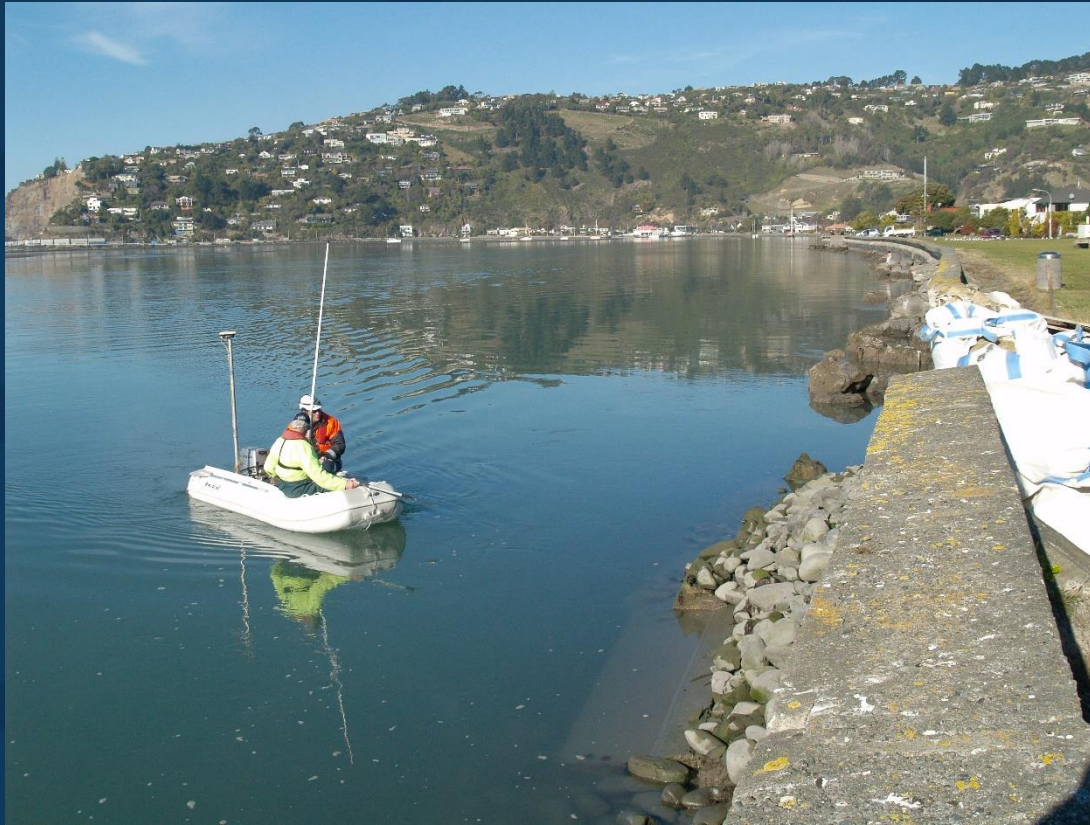
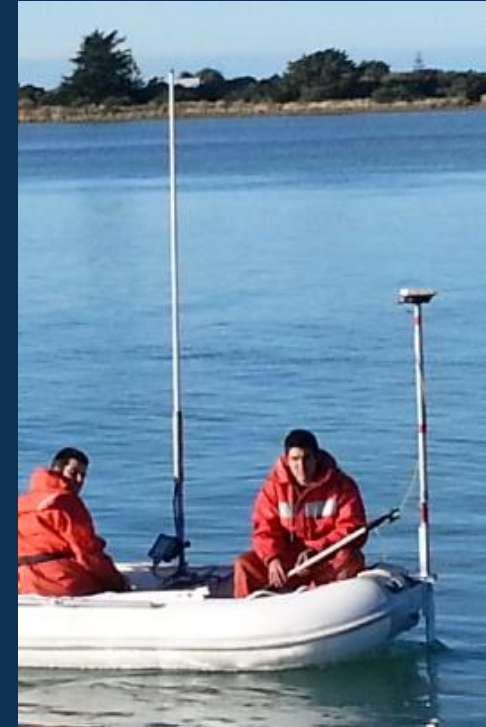
# Redcliffs Seawall collapse

500 KHz E/S Bow mounted
