Geospatial Analyses of Mining-Induced Land Degradation Sites in Jos South Local Government Area, Plateau State-Nigeria

Adamu BALA, Samuel GARBA, Taiye ADEWUYI and Terwase YOUNGU, Nigeria

FIG e-Working Week 2021
Smart Surveyors for Land and Water Management - Challenges in a New Reality
Virtual, 21–25 June 2021

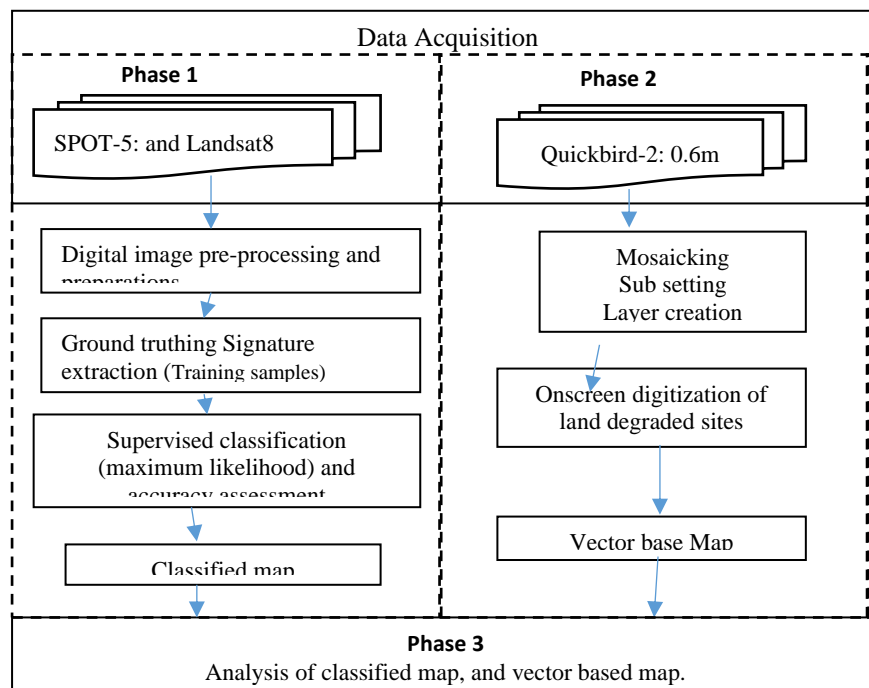
Figure 2: Methodology workflow diagram (after; Bala, 2018)

The reconnaissance survey and field familiarisation of the study area were carried out as the first step of the research. The workflow diagram in Figure 2 is in three sections according to the stages adopted. The first stage entailed data collection (the process of acquiring data necessary for the research). The pre-processing and correction for errors of both the SPOT 5 and Landsat 8, were then carried out, trailed by layer stacking and merged resolution. Ground truthing and signature extraction were then carried out prior to the supervised maximum likelihood classification of the imagery, and the accuracy of the classification was assessed. The second stage was the pre-processing and correction for errors, mosaicking, subsetting and layer creation of high-resolution Quickbird-2. This was followed by on-screen digitisation of the degraded sites. The final products were the maps of the degraded sites together with analyses of their attributes.

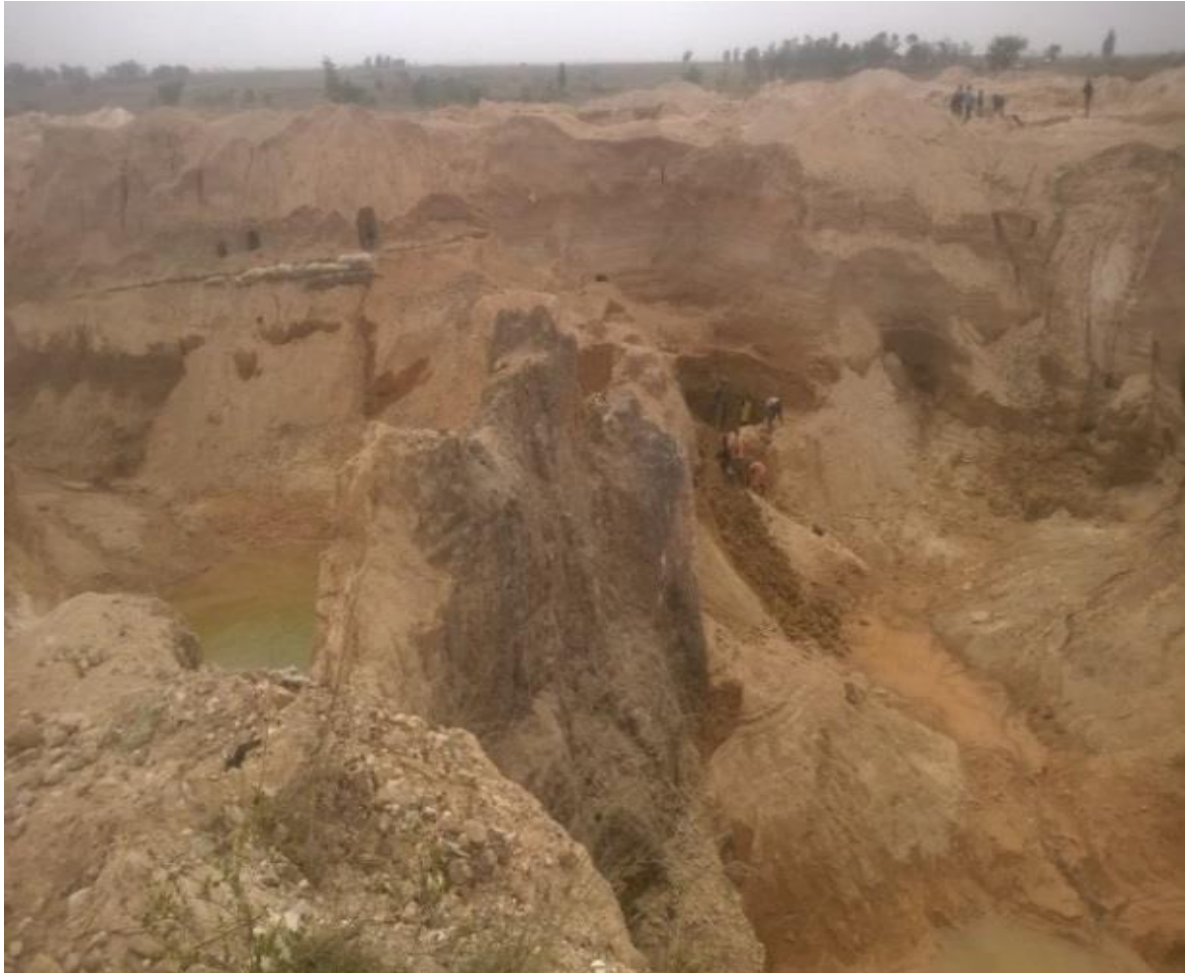
Figure 4: Active Mining Site at Kuru Janta Mines (10/11/2015)

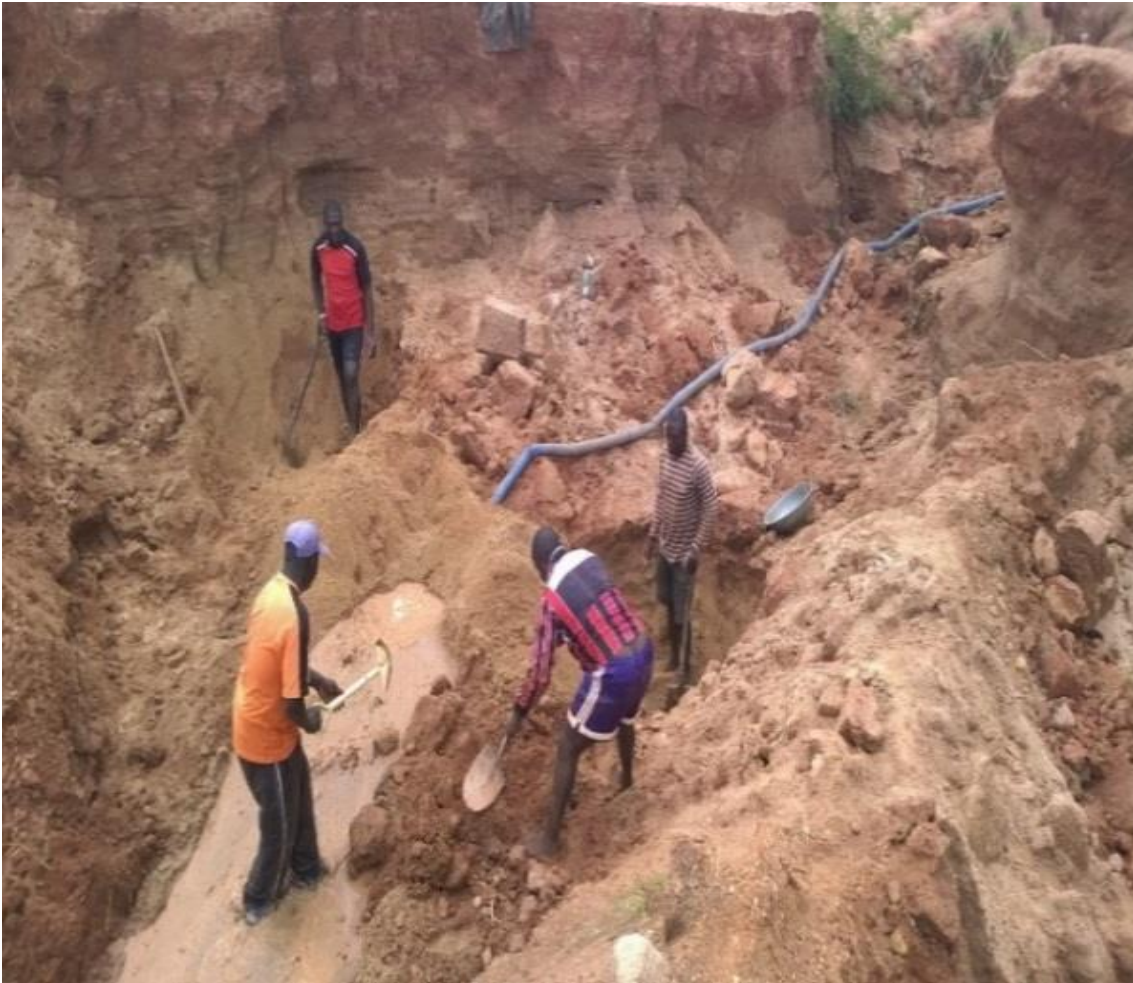
Figure 5: Searching for Tin and Columbite at the ‘Rayfield’ Resort Centre Site (03/06/2015)

high altitude of the area and steep slopes make water erosion common, especially in the rainy season. It was observed that mining activities were still going on in some sites at the time of the visit (Figure 5).
