Presented at the FIG Working Week 2016,
May 2-6, 2016 in Christchurch, New Zealand

EQ Response

- Mark Christison
- David Heiler
- Amber Murphy
- Greg Offer

Damage Investigation and Analysis

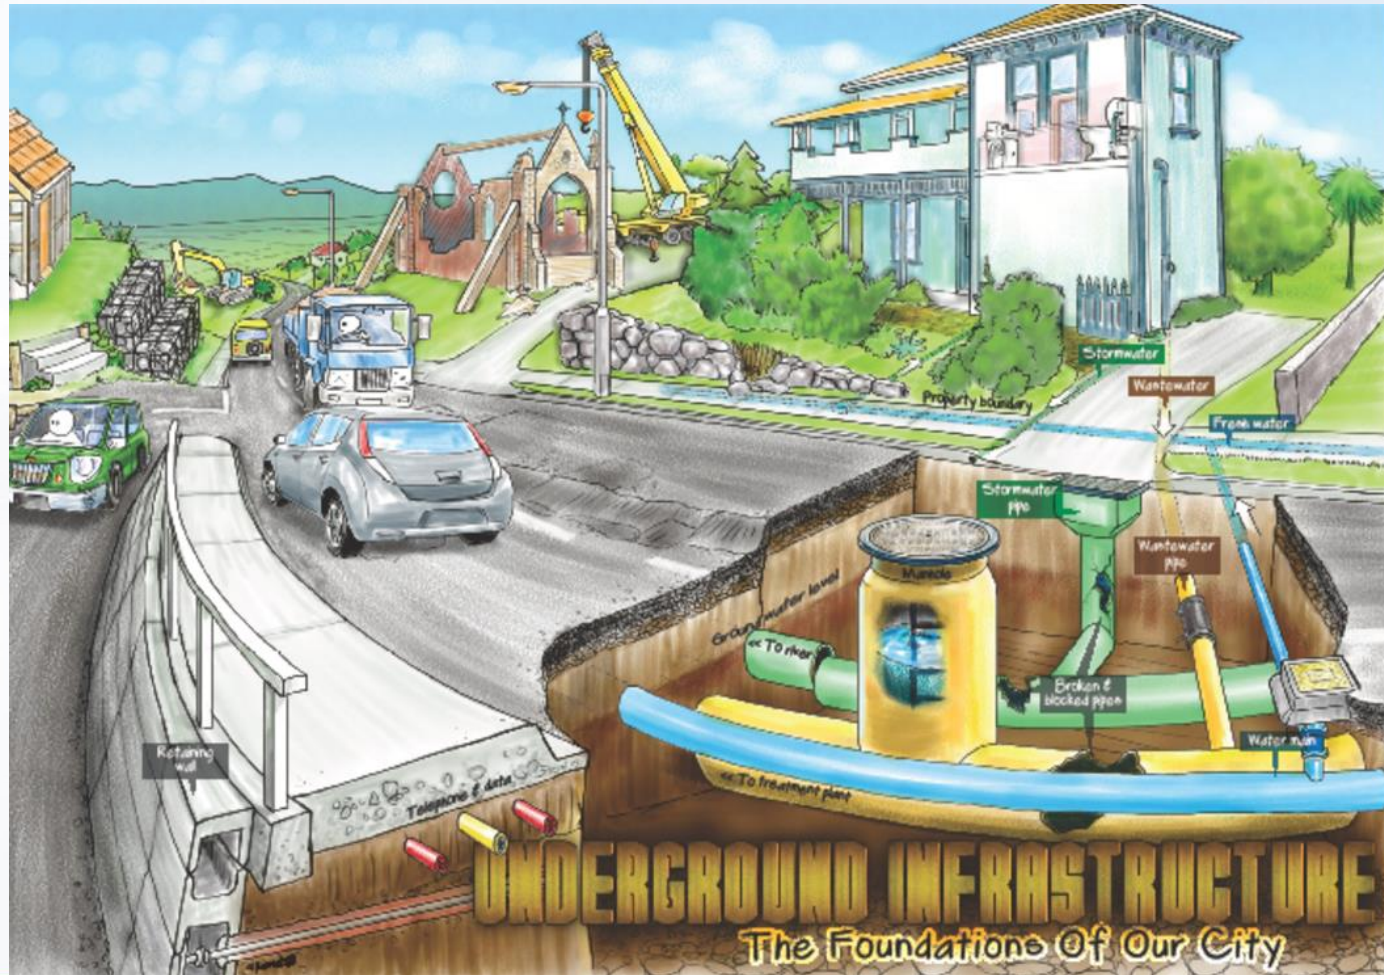
Other damage harder to assess

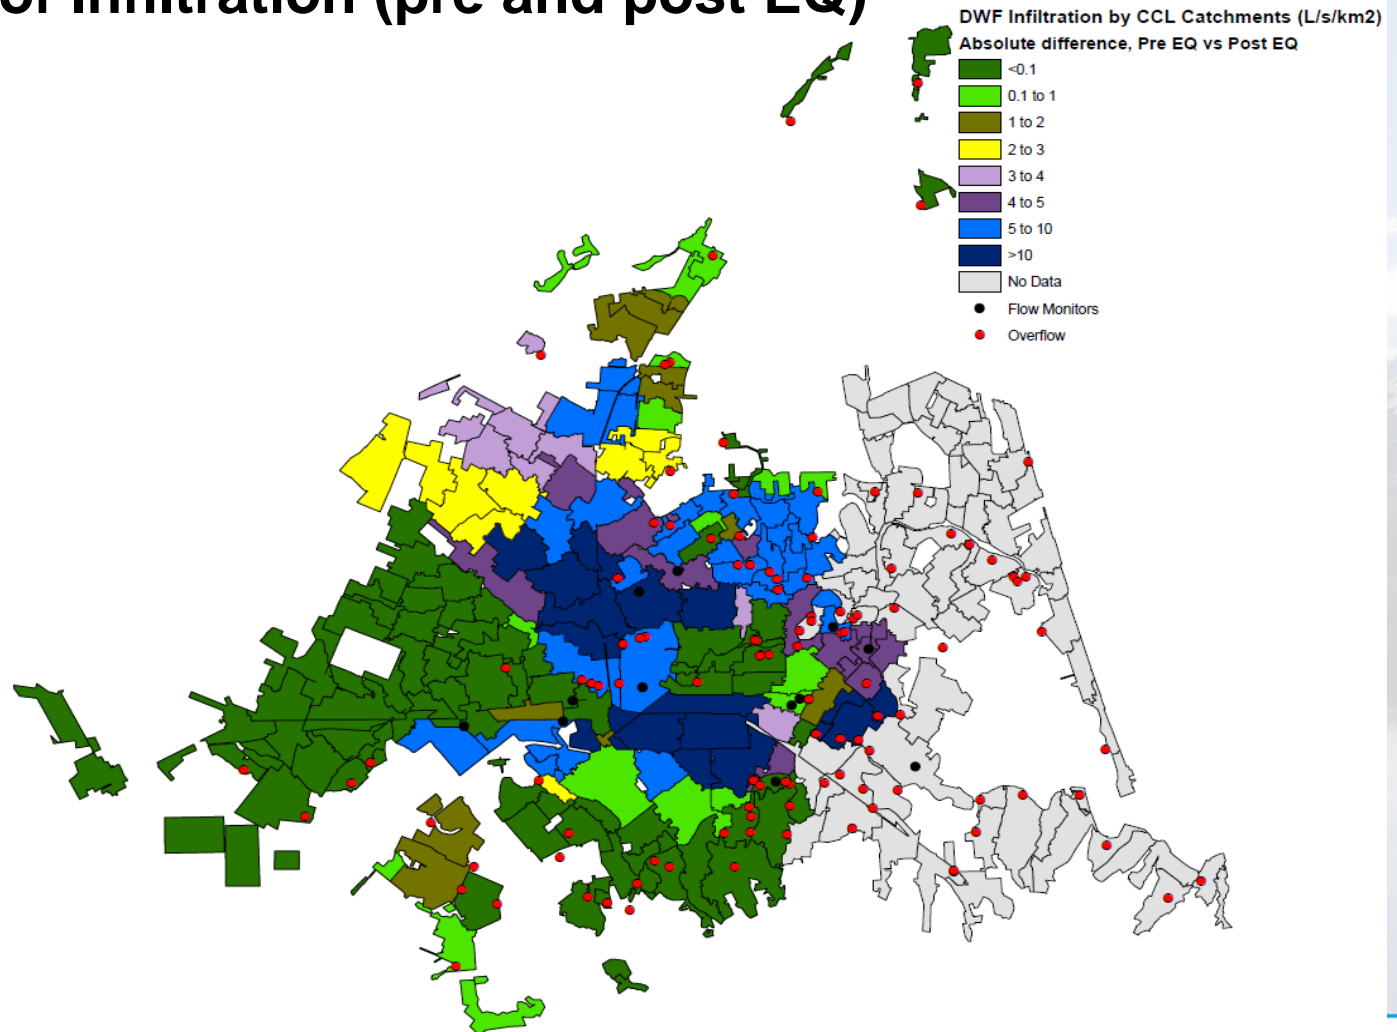
Comparison of Infiltration (pre and post EQ)

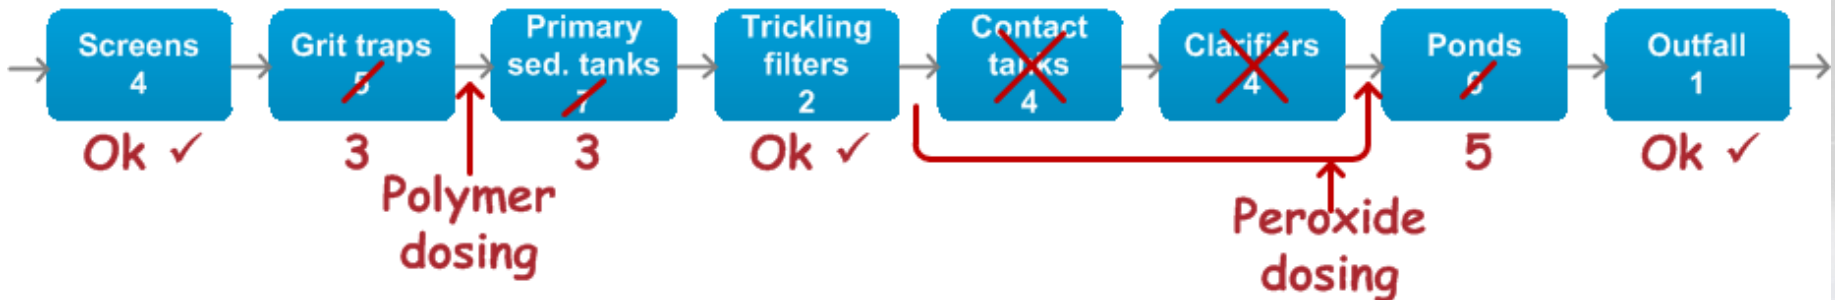
- Built at shallow depth so lightly damaged
- Some media and rotating arm damage
- External ring beam to strengthen tank
- Online 24/7 means inspection difficult... insurer wants “whole of site settlement”

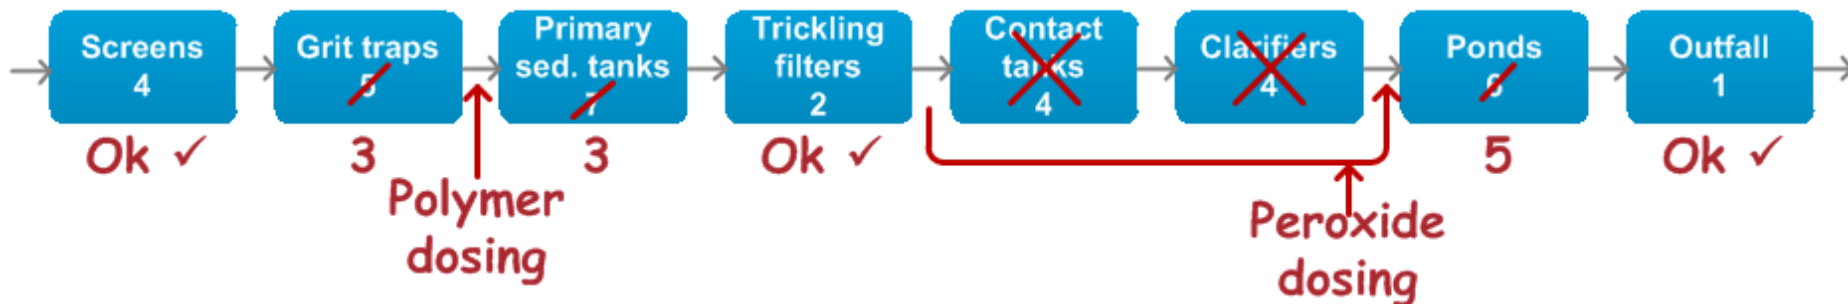
- Two clarifiers severe damage, two minor damage
- Liquefaction pore pressures caused floor deformation
- Repairs based on reinforced concrete overlay
- Cure-in-place liner installed on inlet pipes
